# TARRYALL/CLINE RANCH

South Park - Park County, Colorado

## Historic Structure Assessment

October, 2011

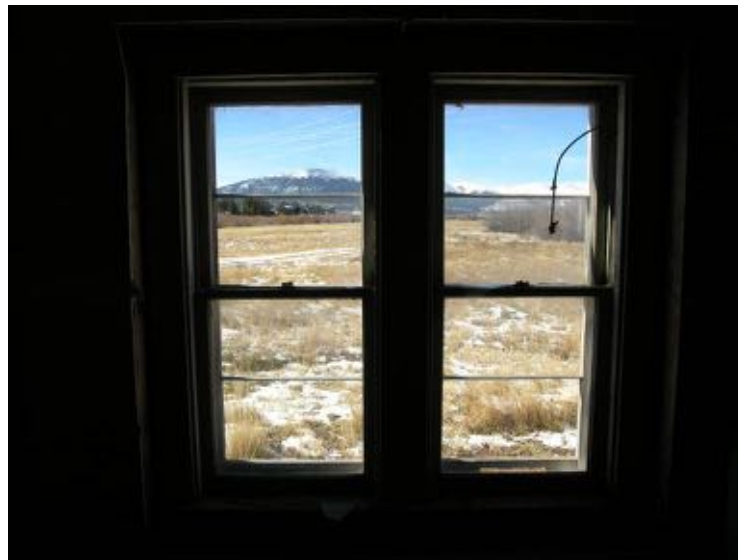
View to the west from the Main ranch house 1st floor bedroom. Note that the sash rope is detached.

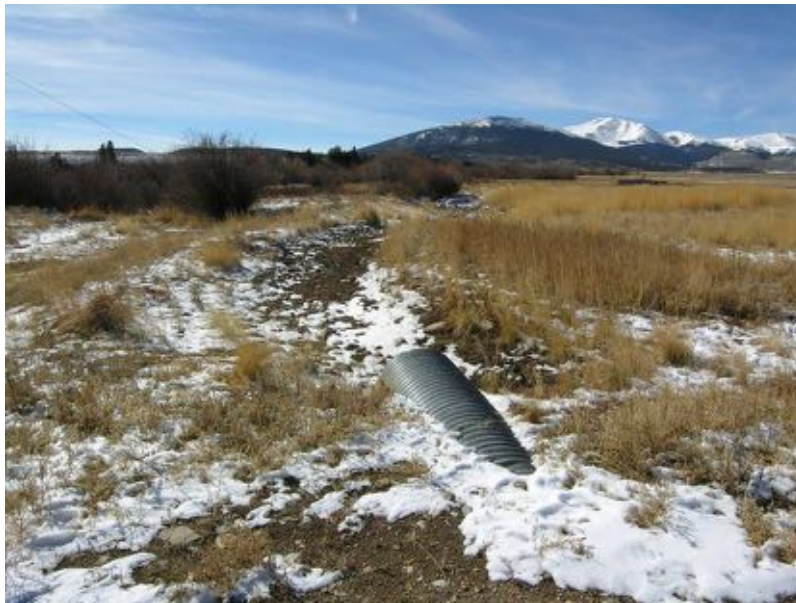
Culvert pipe to the north of the main ranch house with a small drainage channel.

Since the site is so flat, there is insufficient drainage around the buildings, particularly the main ranch house. It is clear that moisture pools around the foundations of the structures. Overall, the condition of the site is poor, due to insufficient drainage away from the buildings. Contributing to the site drainage problems is the proximity of the waterways and associated high water table.

2. Regrade the property around the buildings to achieve positive drainage away from the foundations. Develop a 4-5 foot dry zone at the foundations with gravel to discourage plantings and irrigation next to the buildings.

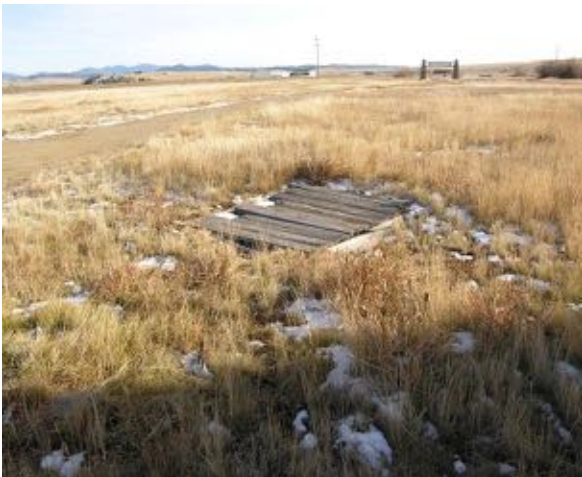
The well cover is wood planking set on the ground above the well and vulnerable to deterioration or a vehicle inadvertently driving over it in the winter.

3. Consult with a well contractor and evaluate the cover for the well. Design, fabricate and install a new well cover, better designed against dangerous failure.

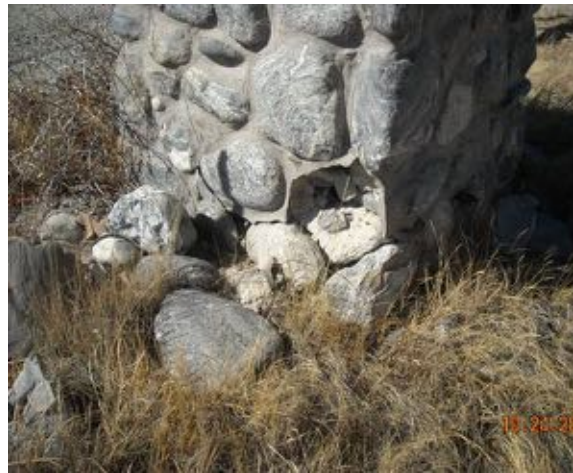
The stone work of the gate posts has deteriorated and needs repair to carefully match the original mortar, tooling and setting.

7. Rehabilitate the stone masonry gate posts and repair and repaint the wood sign board as needed. Reset loose or missing stones with mortar to match the original mortar in all aspects – color, composition, aggregate and tooling.

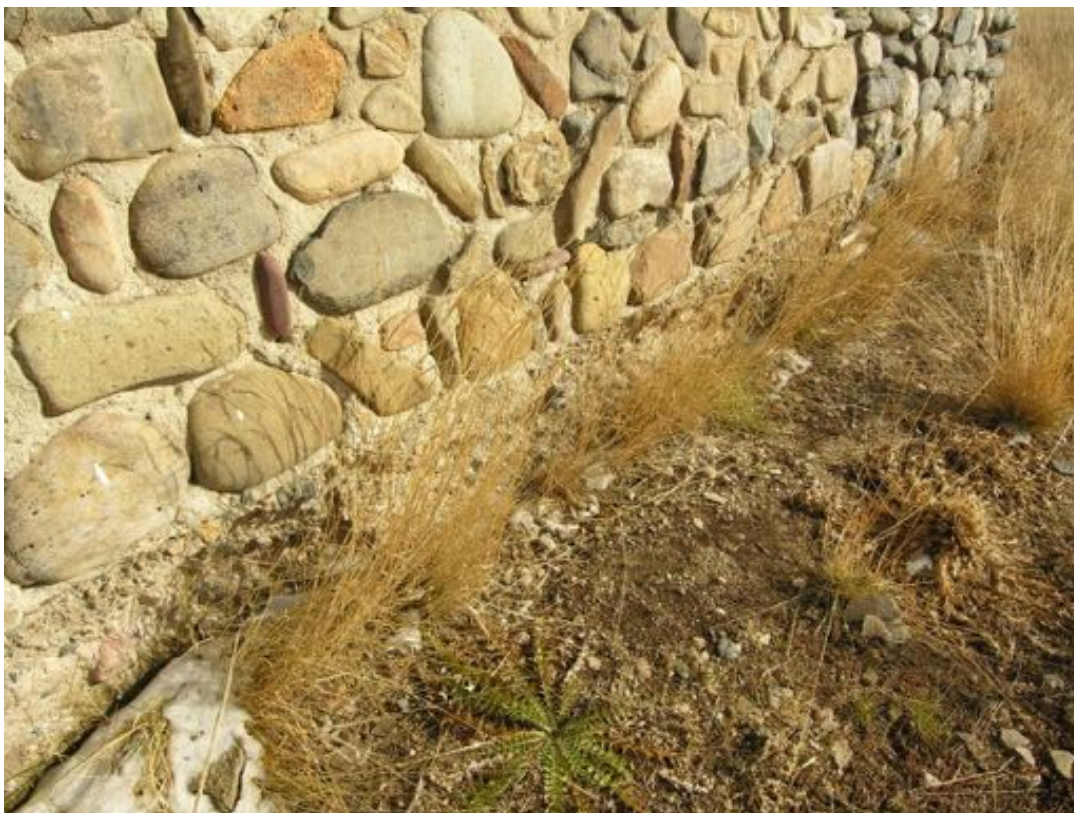
Foundation of the main ranch house with a spalled and eroded concrete footer and a rock masonry veneer wall above.

The condition of the poured concrete footer of the main ranch house is extremely poor. This footer is not entirely visible, but where it is, it shows a considerable amount of deterioration. The concrete of the footer is light tan in color with large aggregate and it has a very rough and eroded surface. The mortar used to build the veneer rock wall above the footer is similarly colored and the aggregate is very large for mortar. Clearly, the aggregate was obtained locally originally, probably from the riverbed, and the tan color of the concrete and mortar indicates that soil was mixed in with the aggregate, weakening the strength. It would appear that another factor in the weakness of the concrete is an inadequate proportion of portland cement in the original mix. This concrete of the footer has spalled, eroded and crumbled, causing subsidence and collapse of the rock veneer wall. On the east side of the house, support for the framing and parts of the floor system is now lacking, due to failure of the footer concrete. The stone and mortar veneer wall is also in poor condition, in some cases obviously because of a failure of the supporting footer, in other locations, the veneer wall appears to have buckled and

It is necessary to replace the existing inadequate foundation and this can be undertaken in several ways: typically, a building shored and supported and then jacked up, a crawl space excavated and new foundation poured under the house and then the building is lowered onto the new foundation. The problem with this method is that it

would involve separating the heavy masonry front porch from the house, a risky and potentially destructive procedure. The other method for this house would be to replace the foundation in sections. The house would be shored and supported and the excavation would be accomplished a section at a time creating a crawl space, including construction of all interior support walls and installing the new foundation in sections. The end result would be the same new foundation as the first method. For the purposes of this study, I recommend and obtained pricing for the second method.

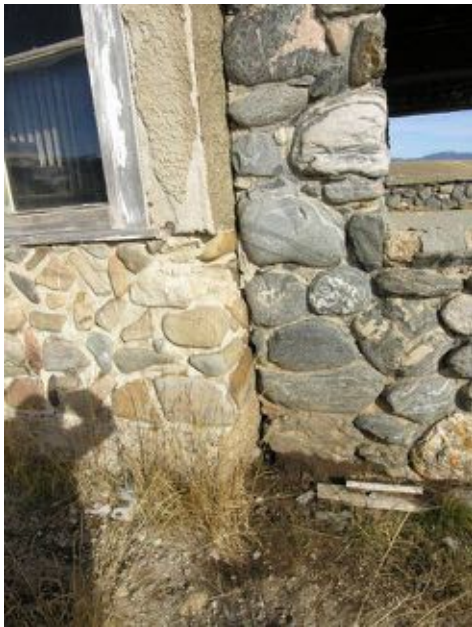
Southwest corner of the house at the joint with the south entry porch, note the differences in the masonry types. Also note the concrete footing and stone masonry veneer wall of the house foundation.

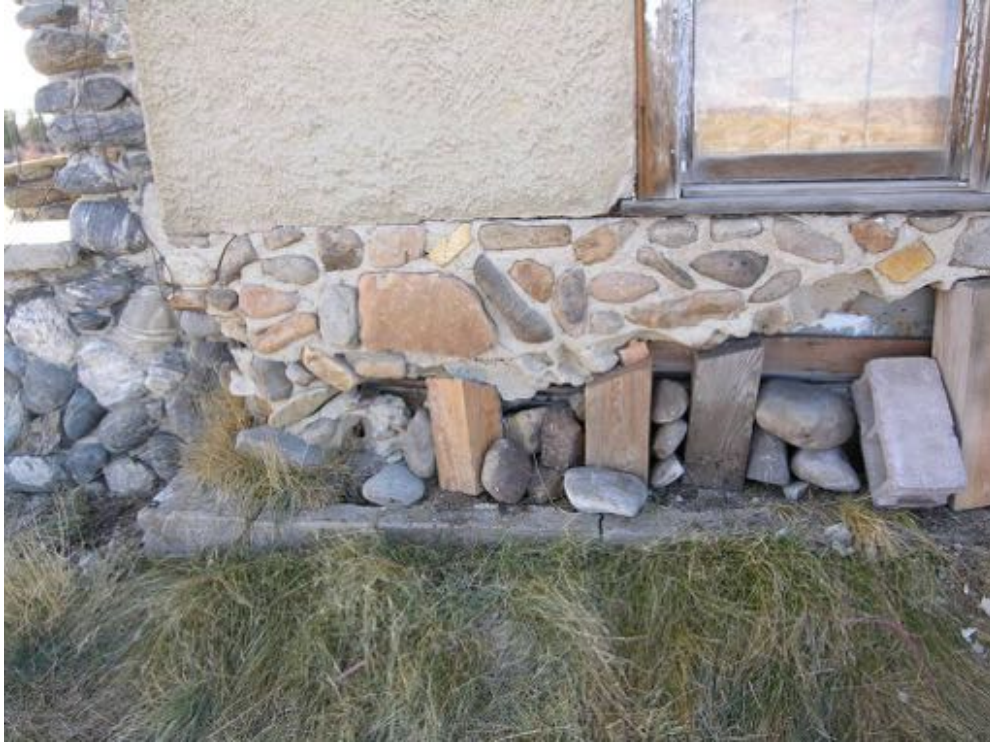
Detail of the foundation condition at the east side of the house. Here the footer has clearly failed, allowing both the interior framing to settle and be unsupported, but causing the exterior stone veneer to collapse. In addition, a more recent concrete pad has been added in a failed attempt to shore up the missing support.

disintegrated apparently due to weakness of the mortar as well as the lack of depth and connectors to the wood frame walls and instability of the rock veneer. The primary cause of all this deterioration is moisture penetration of the masonry due to poor site drainage. It is interesting to note that the concrete and masonry of the west elevation is in much better condition than the east elevation, indicating that site drainage is better on the west.

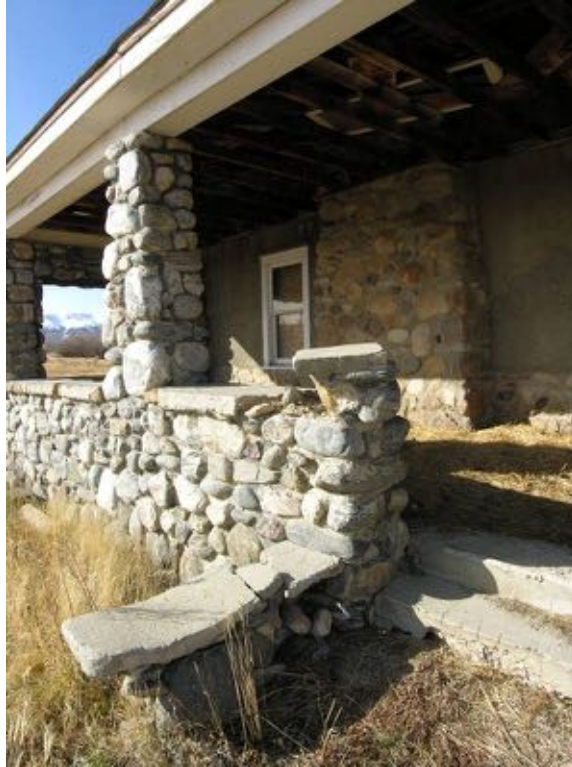
The main entry porch on the south elevation, the walls of the porch are structurally sound, but the concrete floor and steps are cracked and deteriorated.

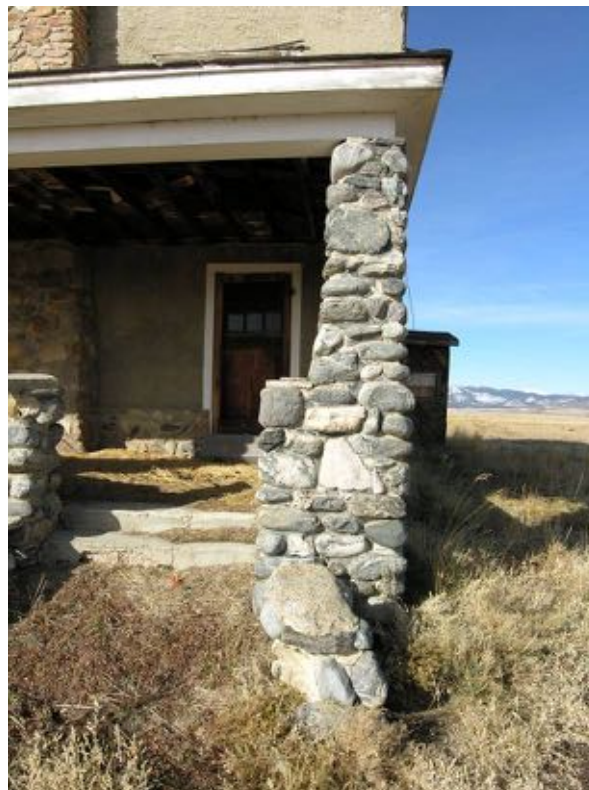
The main entry porch on the south elevation, the walls of the porch are generally structurally sound, but the concrete floor and steps are cracked and deteriorated.

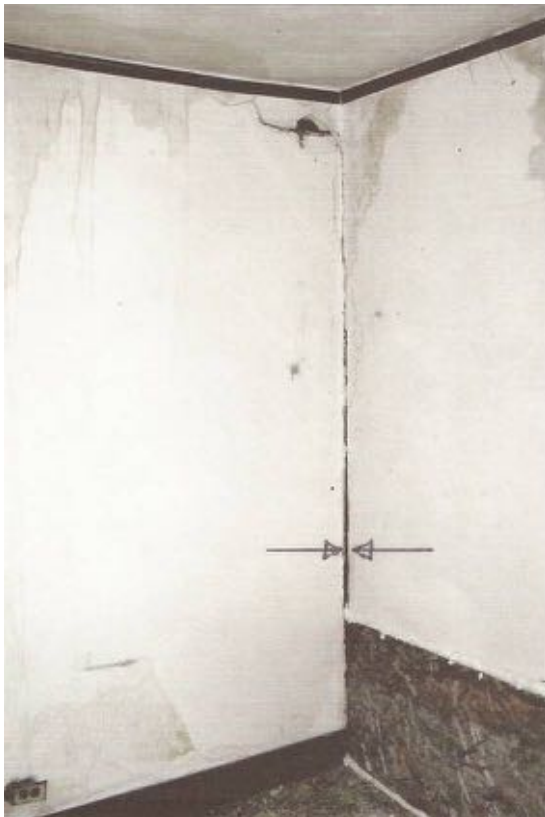
Room 101, the Living Room, there is a structural crack in the corner where the foundation has failed, causing the wall and floor to be unsupported and daylight shows through the floor where it should be attached to the wall and foundation.

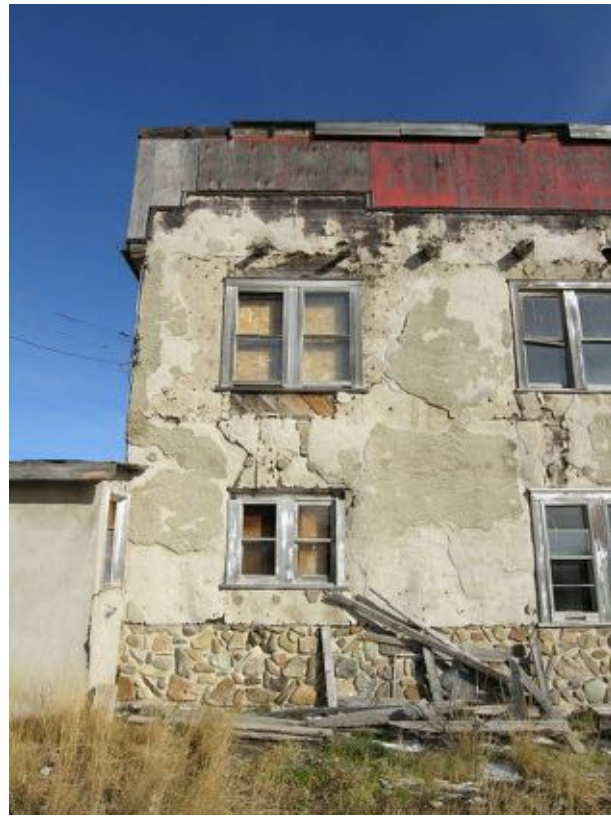
Exterior of the west wall, note the exposed diagonal wood plank sheathing where the stucco has failed.

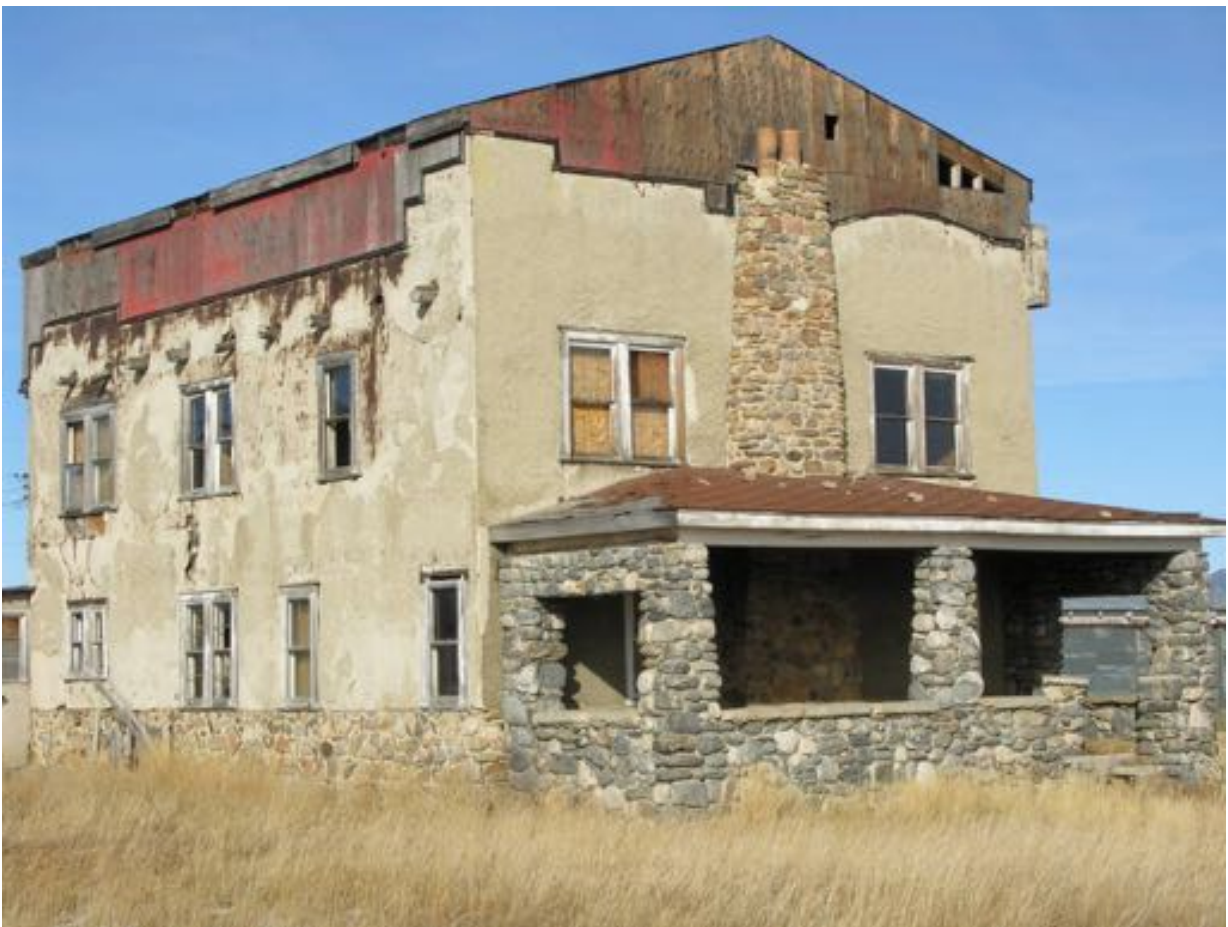
The Cline main ranch house, view from the southwest, showing the deteriorated stucco system on the west elevation, including rotted vigas, the stone veneer applied at the base of the west elevation, and the stone main south entry porch.

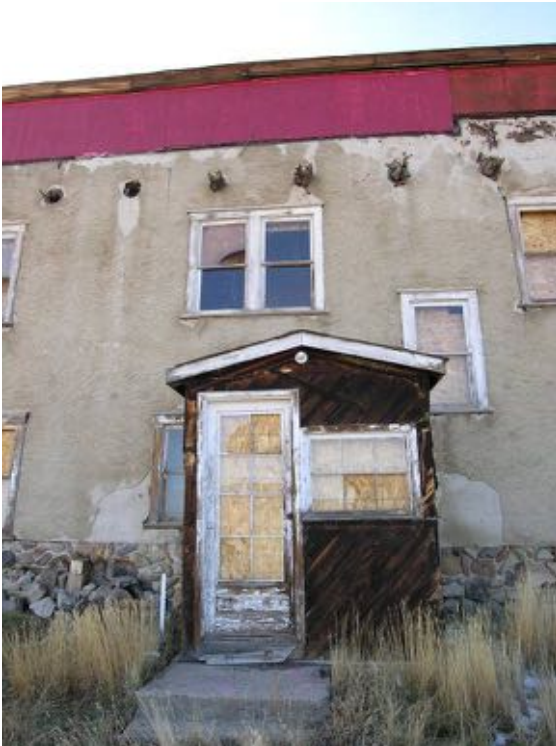
The east entry addition from the 1950s-1960s was never finished with siding or stucco and the original tar paper that was installed on the diagonal plank sheathing did not survive.

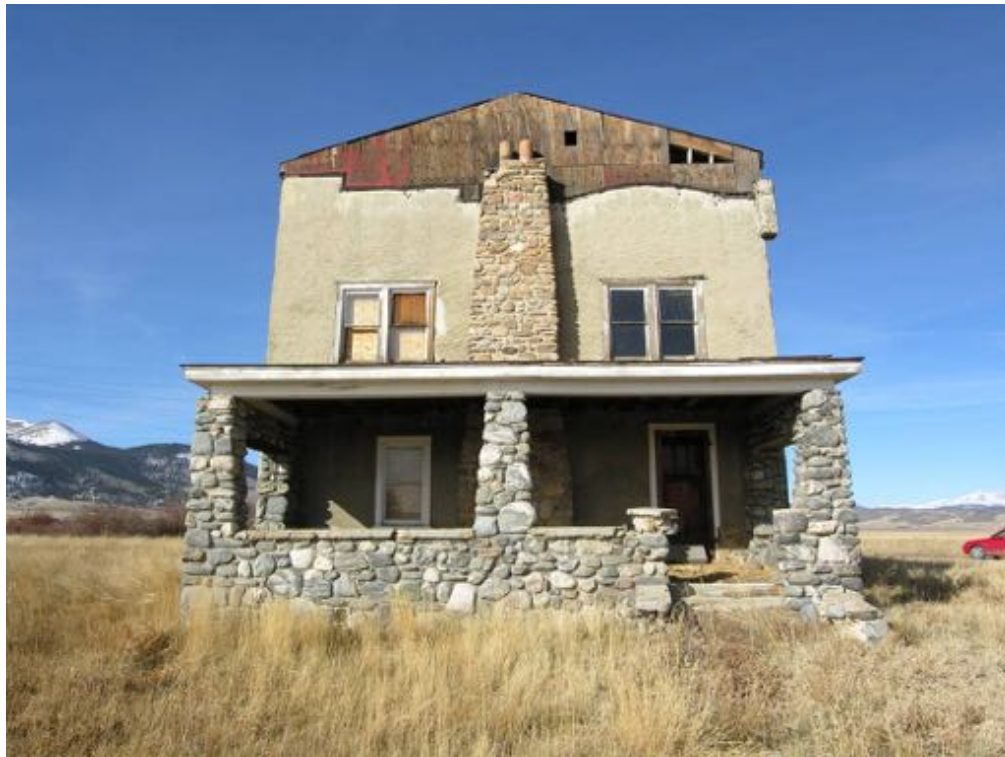
The main south entry stone porch, note the tapered corner columns and the deteriorated concrete ledge caps or sills in the openings.

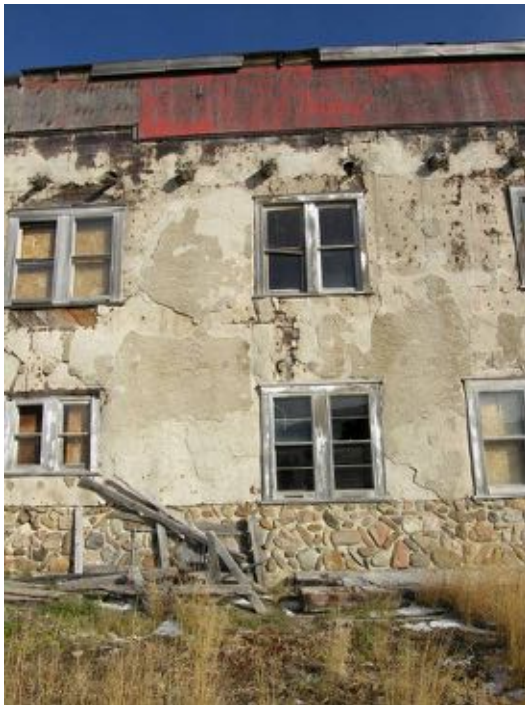
The heavily deteriorated stucco on the west elevation, exposing the wood sheathing in places on the walls. Also note the rotted or missing vigas (log ends).

The vigas will all need to be replaced to match the originals, but with treated wood to prevent rot and appropriate flashing to prevent moisture intrusion.

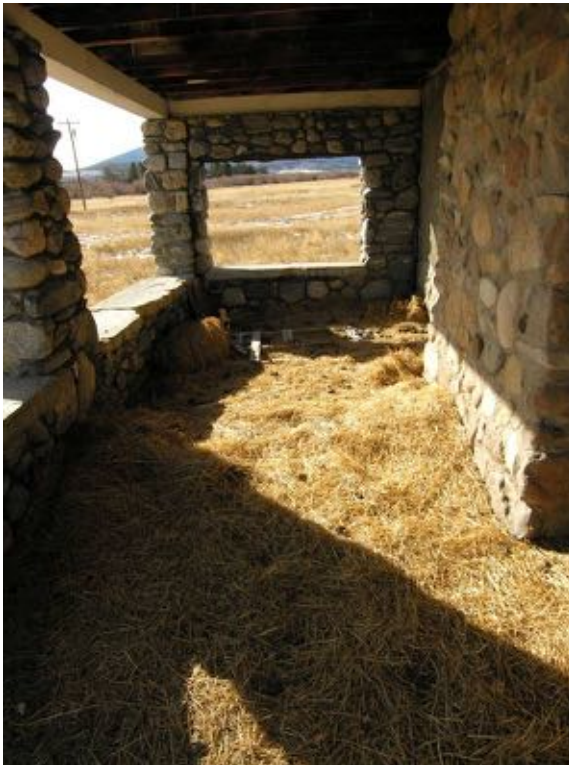
The main entry porch on the south elevation, view to the west; note the spalled and eroded concrete sills or ledge caps. The heavy layer of hay/straw made it impossible to evaluate the entire concrete floor.

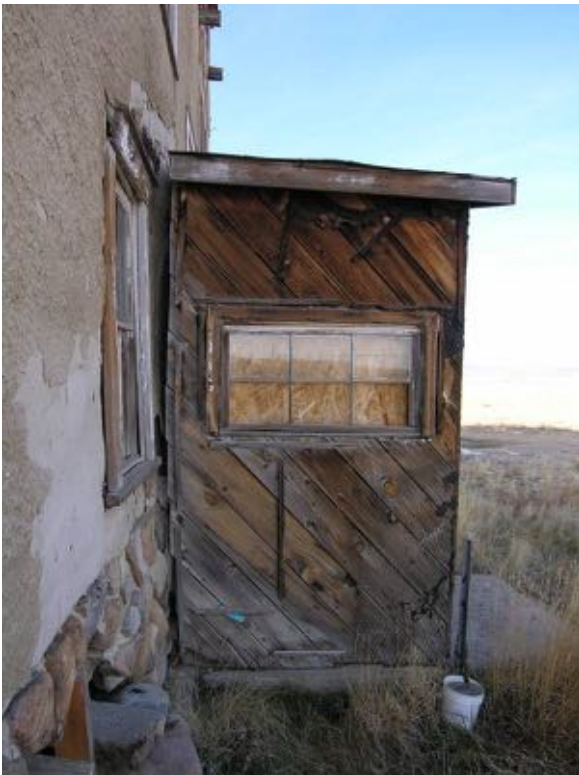
Separation of the entry vestibule on the east elevation of the building.

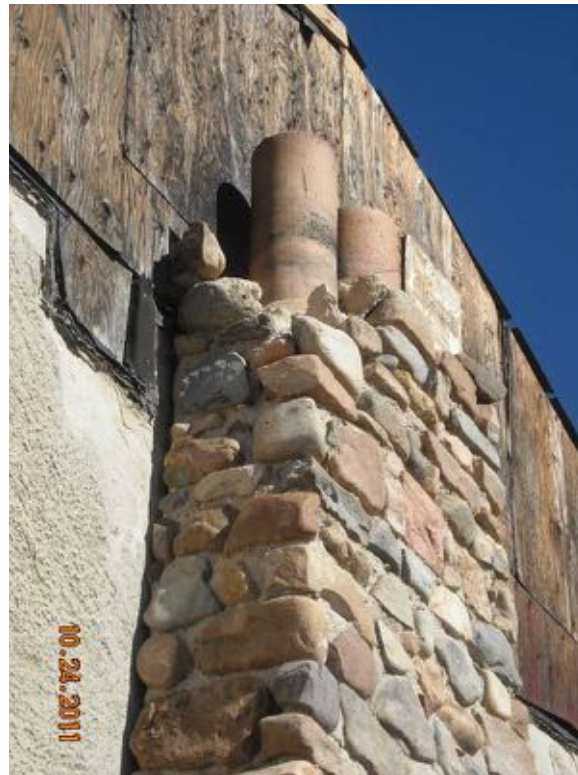
Deteriorated stonework and eroded mortar at the top of the historic south chimney cap.

- Rebuild the upper courses of the original masonry chimneys, repoint where the mortar is missing, loose or eroded.
- Remove the deteriorated and loose stucco from the walls of the house and install new stucco to match the color and texture of the original. Replace the rusted and failed wire mesh with new mesh as a secure base for the stucco.
- Repoint the stone masonry of the front (south) entry porch.
- After the hay is removed from the front porch floor, inspect the concrete floor of the porch and repair or replace as necessary, matching the original finish, color, and aggregate.

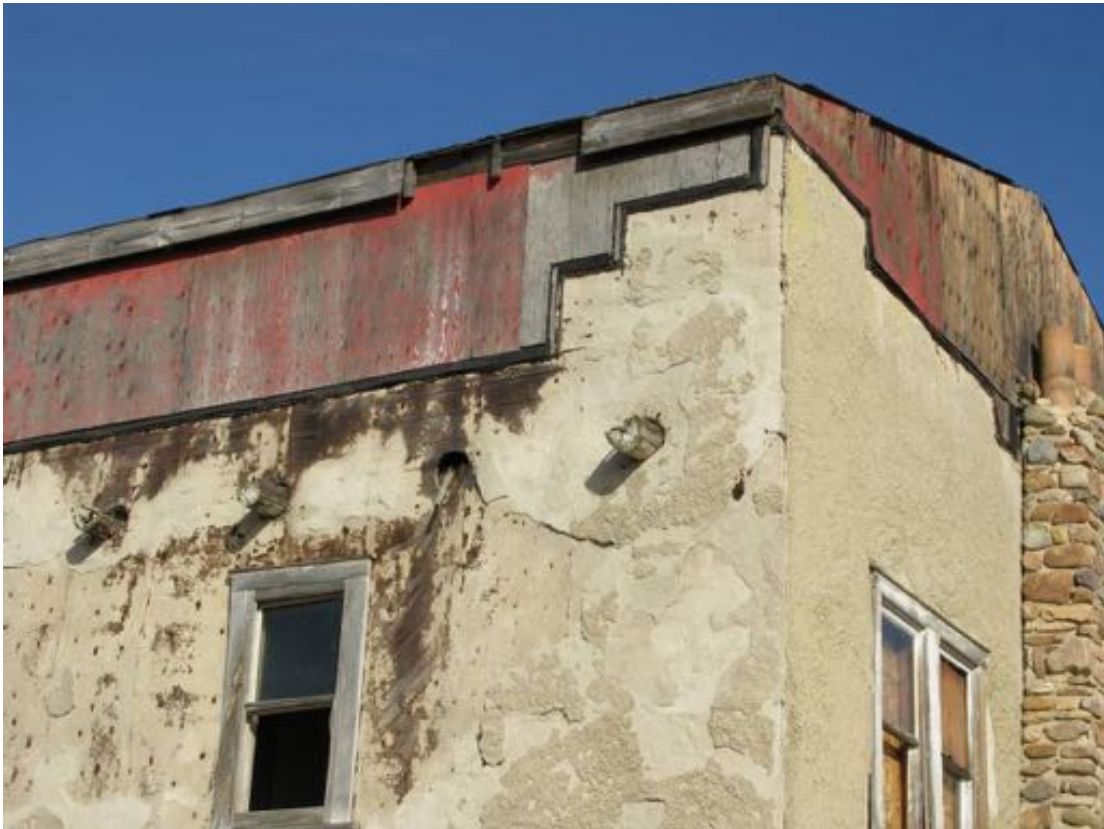
Overframed gable roof built on the parapets, rotted vigas and deteriorated stucco at the southwest corner of the house.

- Carefully remove the wood frame gable roof that overlays the original sloping flat roof without damaging the original parapets and roof deck.
- Remove existing flat roofing and install new seamless, sheet rubber flat roofing on the roof deck with new tapered insulation and new flashing. Consider installing a snow and ice melting system with the new roofing.
- Install a new gutter and downspout along the north end of the roof. It may be necessary to install heat tape or another type of ice melting system at the roof edge and in the gutter and downspout to prevent ice buildup and damming.
- Replace the roofing on the front (south) porch with new asphalt shingles and flashing to match the originals.

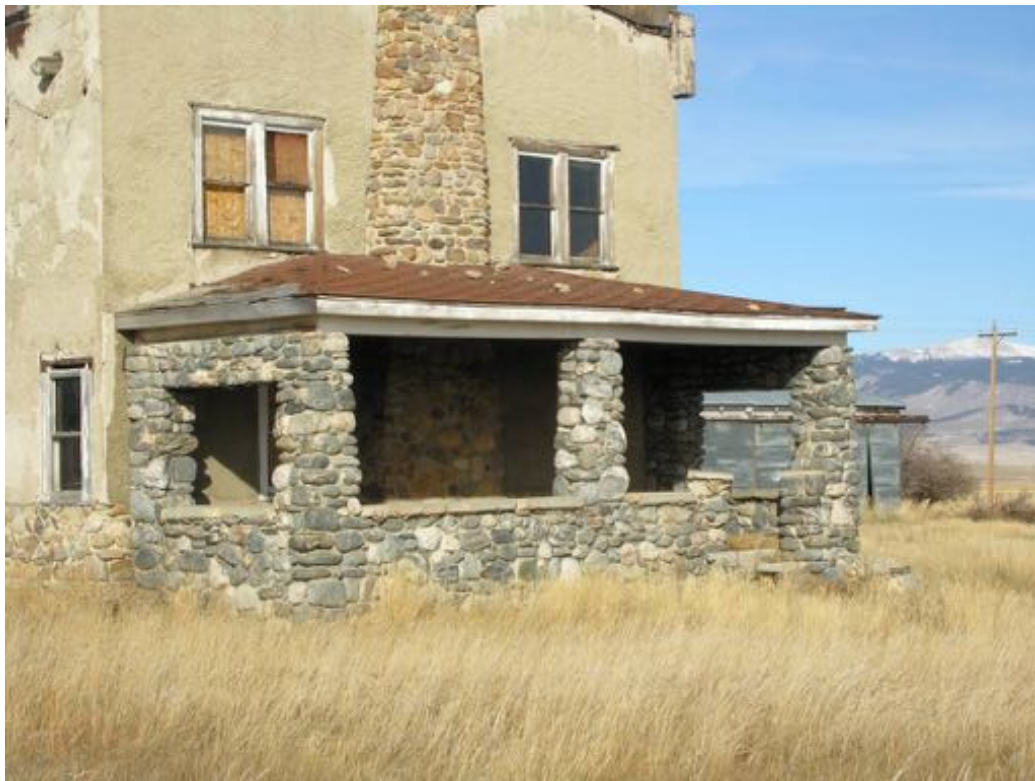
The hipped roof of the main south entry porch shows deteriorated and missing asphalt shingles.

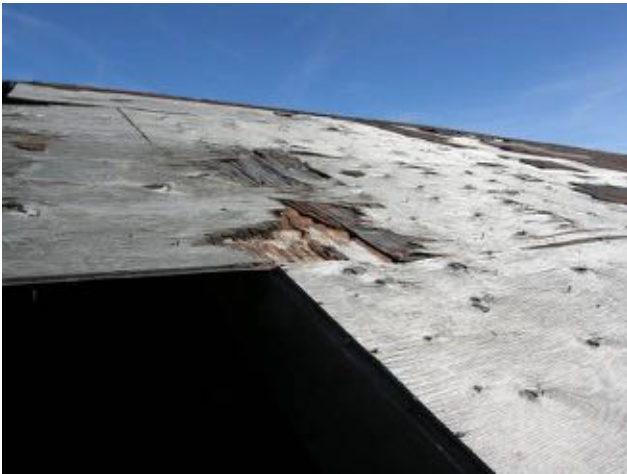
Large areas of the modern gable roof are missing shingles and in this case includes a major hole.

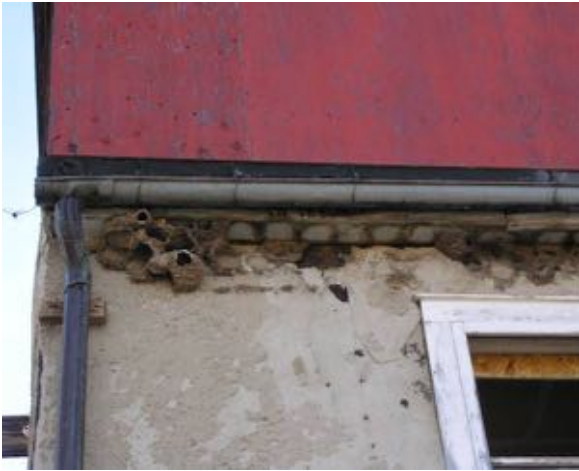
North edge of original roof deck with red painted plywood gable roof above. Note gutter and downspout from the flat roof that is no longer functional with the gable roof and the mud nests from Cliff Swallows under the gutter.

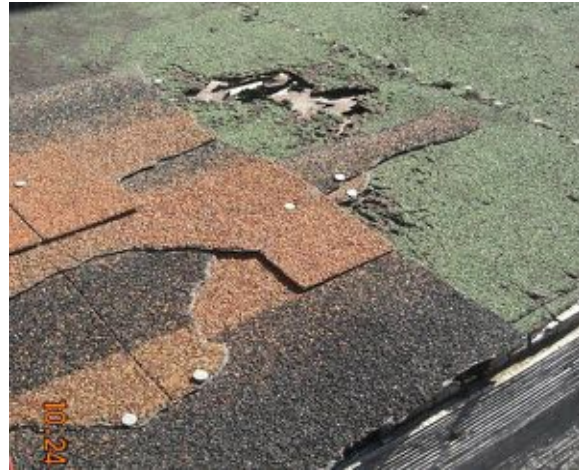
Deteriorated asphalt roofing layers on the north entry addition, note that the green roll roofing is the earliest layer, dating from the construction of the addition in the 1950s -1960s.

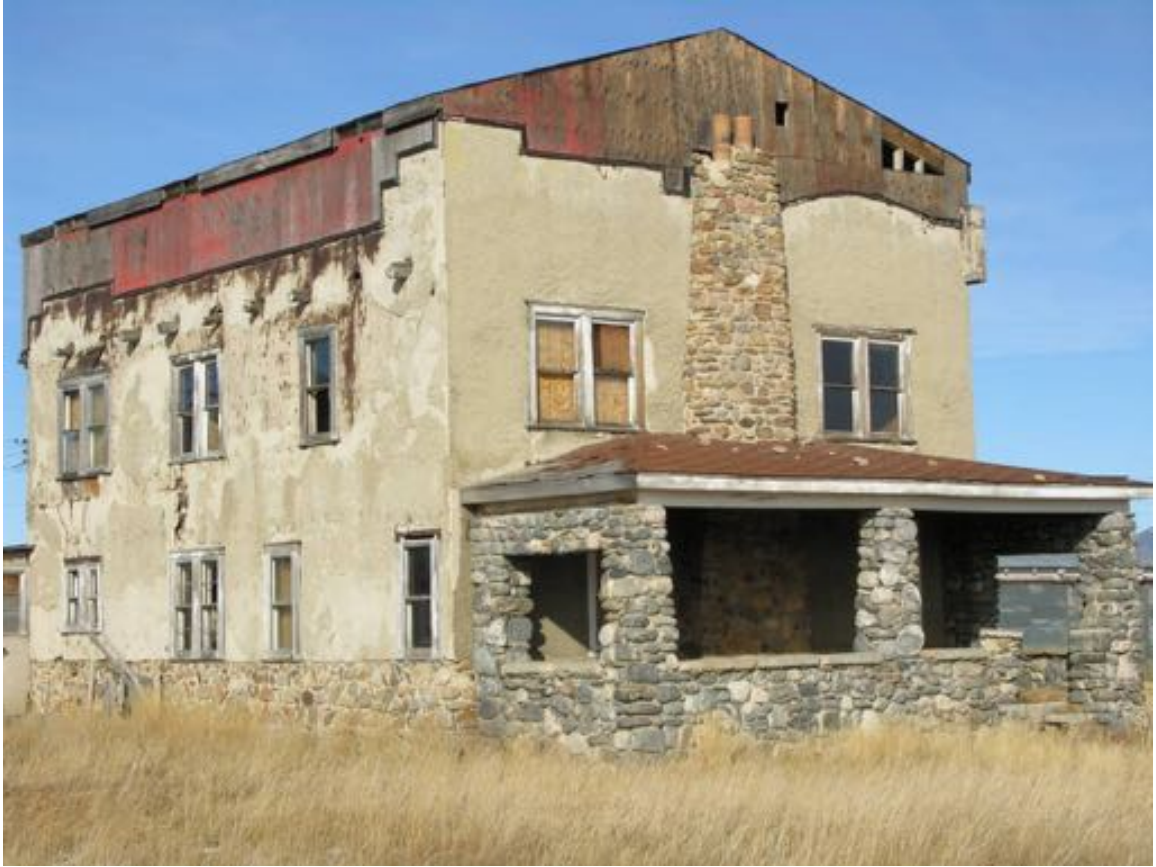
The south and west elevations of the Cline main ranch house, showing the original 1/1 double hung wood windows that are often paired, note that while the glass is broken or missing on many of the windows, the wood sash is intact.

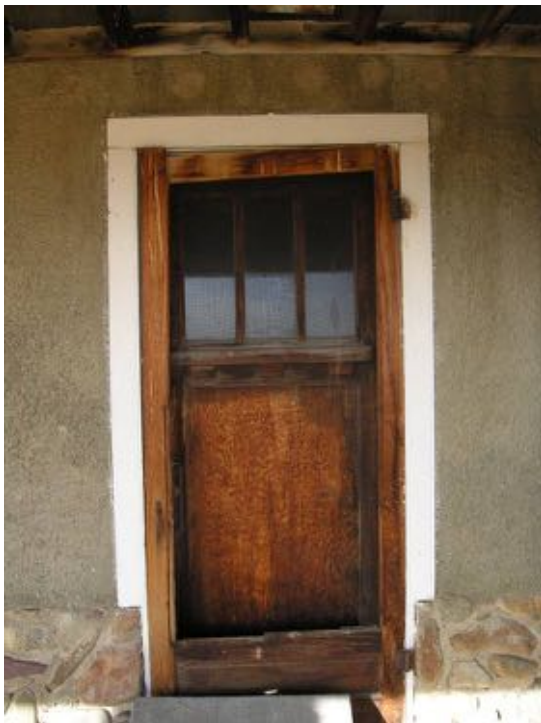
The original south elevation wood main entry door with original hardware and the apparently original wood screen door. Note the damaged screen door and the worn stain and varnish finish on the historic entry door.

- Prepare the painted exterior wood surfaces and prime and repaint using the original color(s) based on microscopic paint analysis.
- Repair and restore the original exterior wood door and wood screen door on the south elevation and the door leading to the kitchen and the kitchen shed on the north elevation. Replicate and install the missing original door on the north elevation, rebuilding the opening and frame to match the original, as documented in the historic photographs.
- Repair and restore the wood window frames and sash, with particular attention to the wood sills. Prime and repaint the original historic color(s).
- Install new unobtrusive storm sash on all the windows.

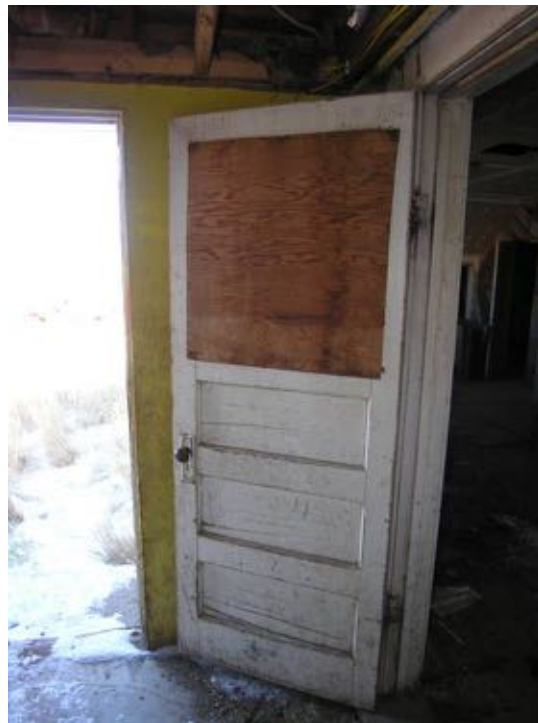
The exterior door within the north entry addition leading to the kitchen. Note the cracked wood panels and glass is missing. This was apparently the original entry door that was moved from the opening at the east end of the kitchen to this location at the west end of the kitchen, within the north entry addition.

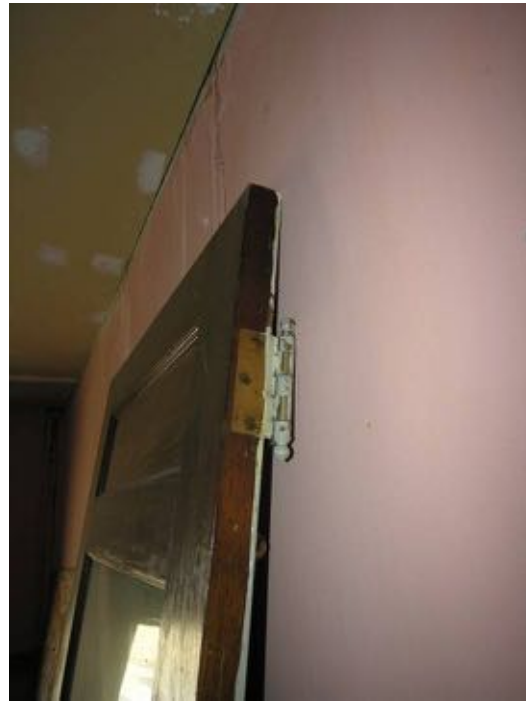
Typical interior hinge hardware, note that this door is one that is missing two upper wood panels, (room #203).

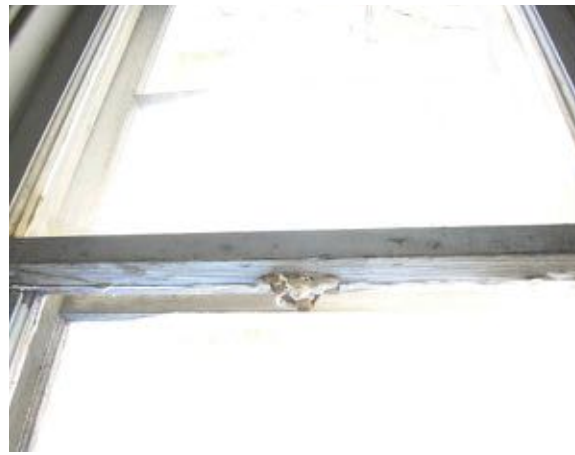
Windows, room #205, note deteriorated paint and the brass sash latch.

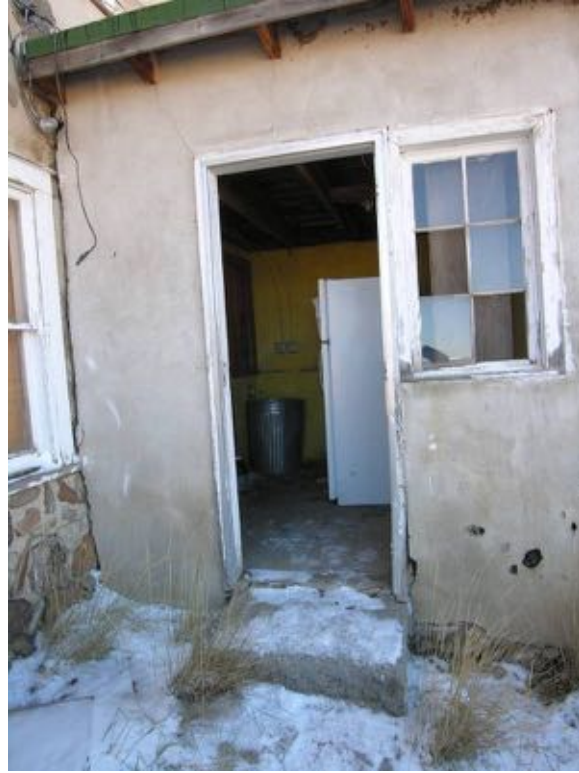
North entry addition. Note that the door is missing, but it is apparently stacked inside the kitchen. Note the broken glass in the window.

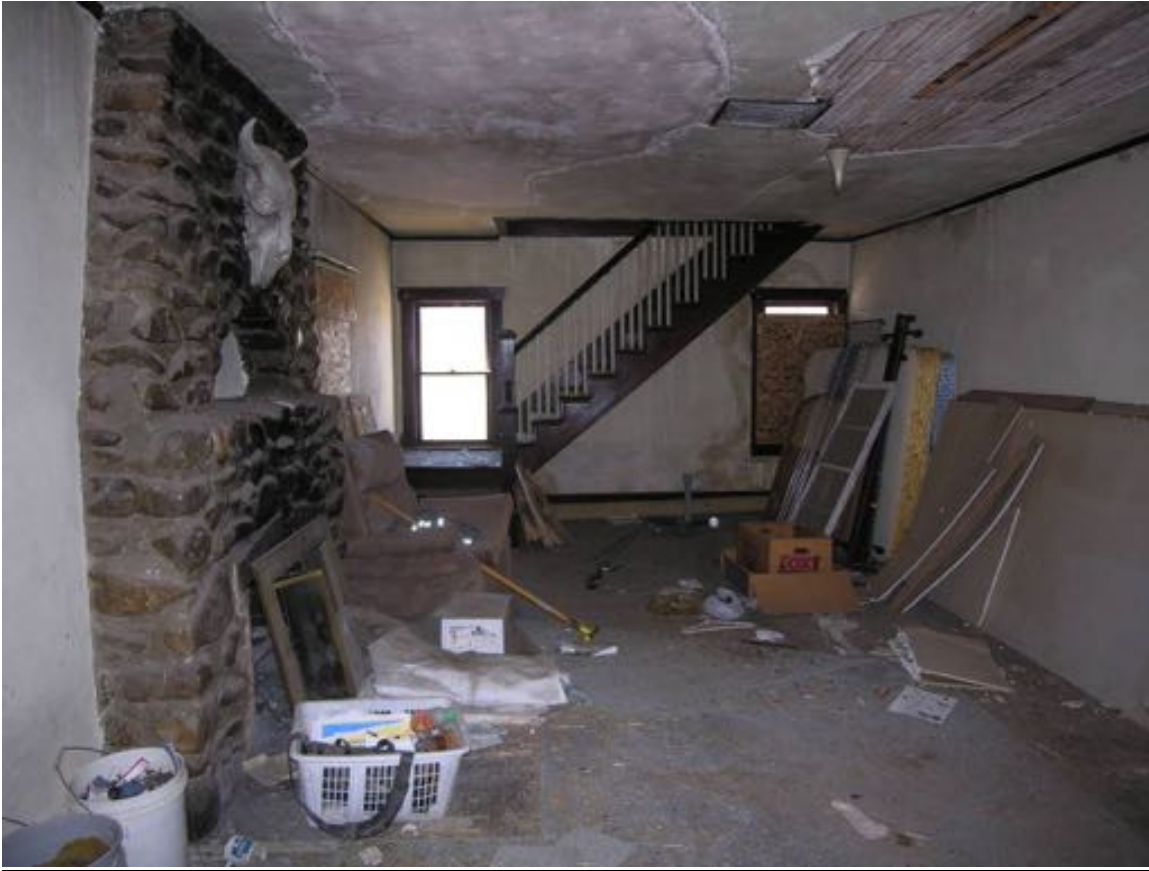
Interior view, first floor living room, view to the west. Note the deteriorated plaster lath ceiling, water damage on ceiling and walls, the original stone fireplace, the strip tongue and groove pine/fir flooring, and stairway leading to the second floor.

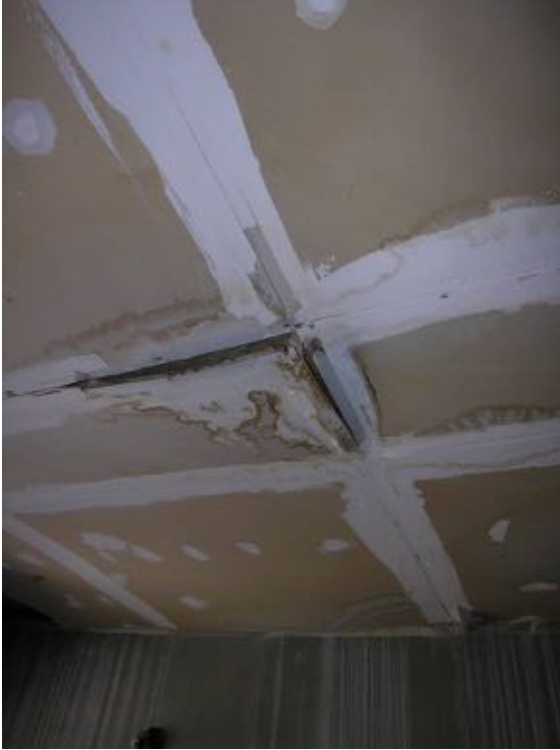
Second floor ceiling showing water damage.

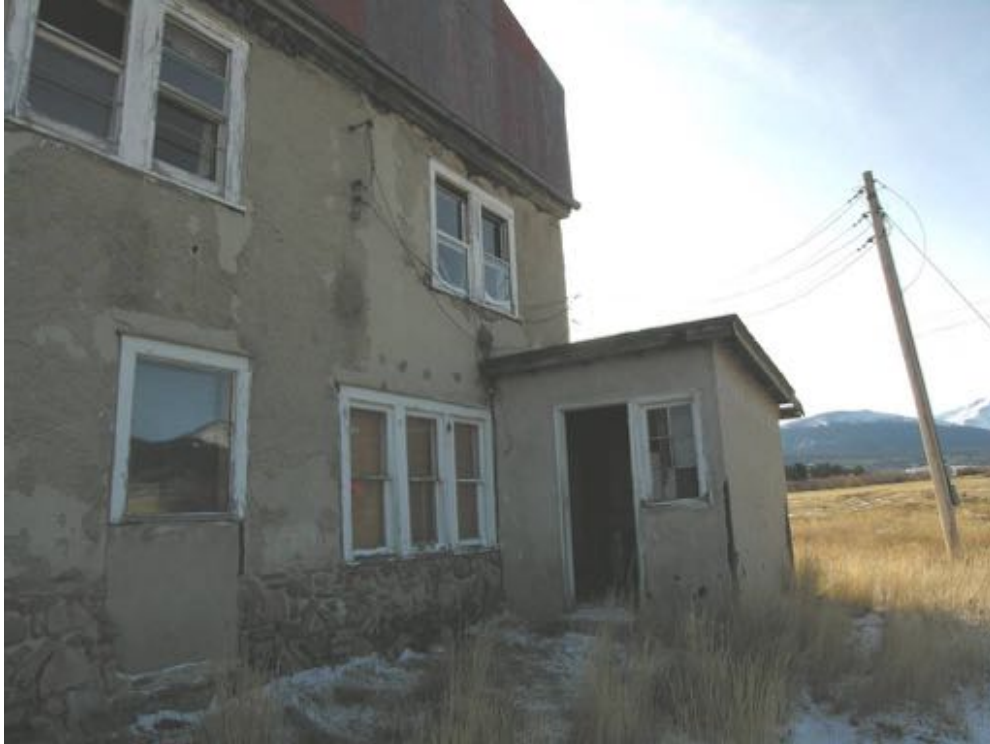
The north elevation, showing incoming electric service to conduit tubes of uncertain integrity.

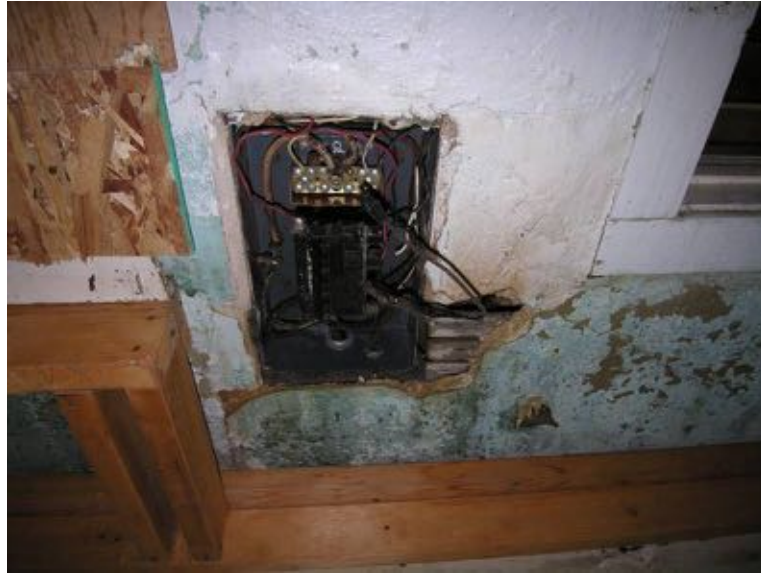
The only visible service panel in the house appears in the kitchen, and is inadequate and out of electrical code compliance.

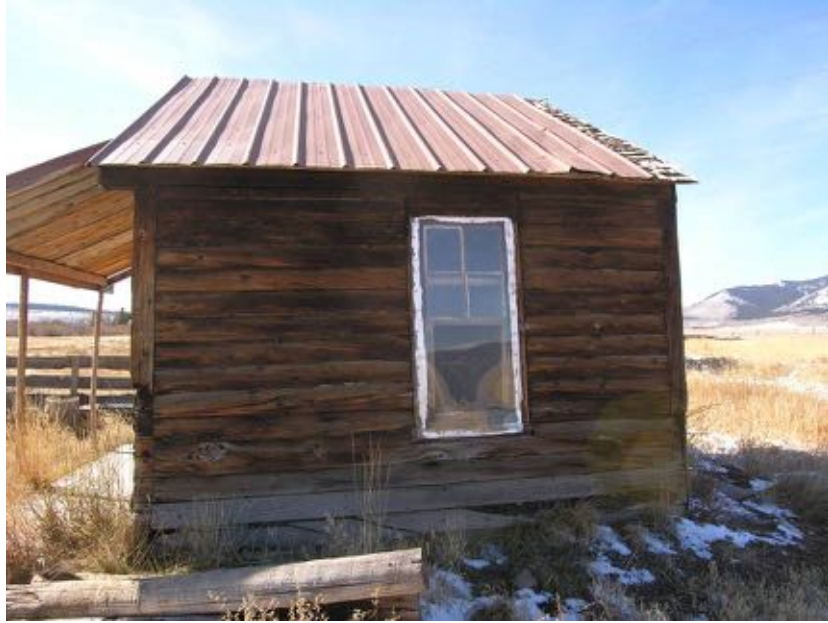
The Cabin, the east elevation, shows no sign of concrete foundation.

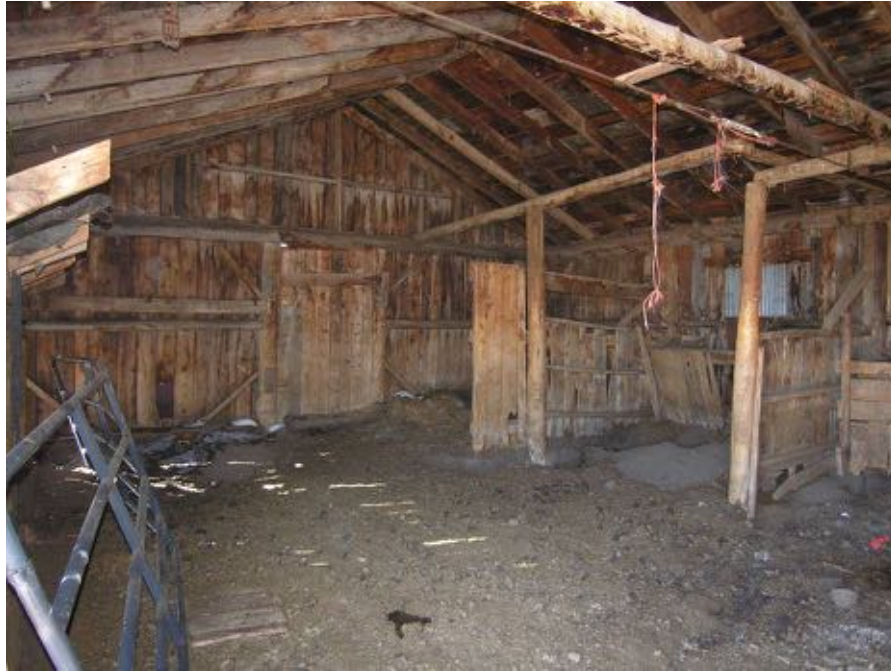
The Barn has steel rod collar ties that appear inadequate to maintain the building shape.

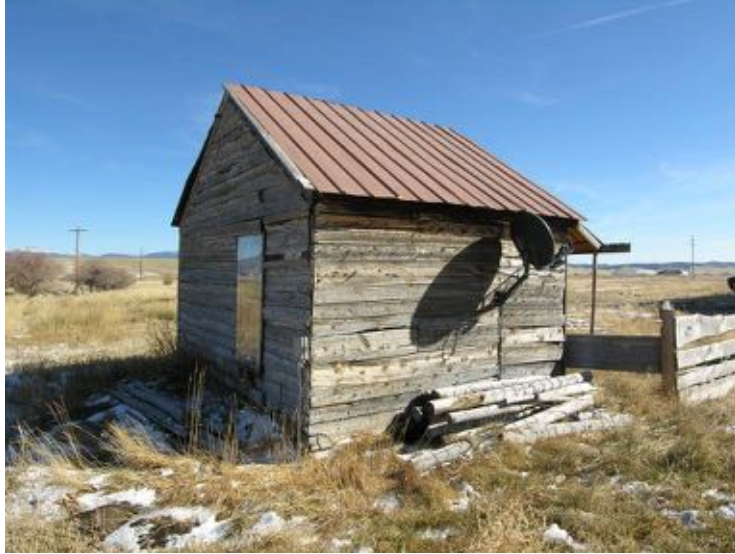
The Cabin, west elevation. The siding appears installed without adequate weather sealing.

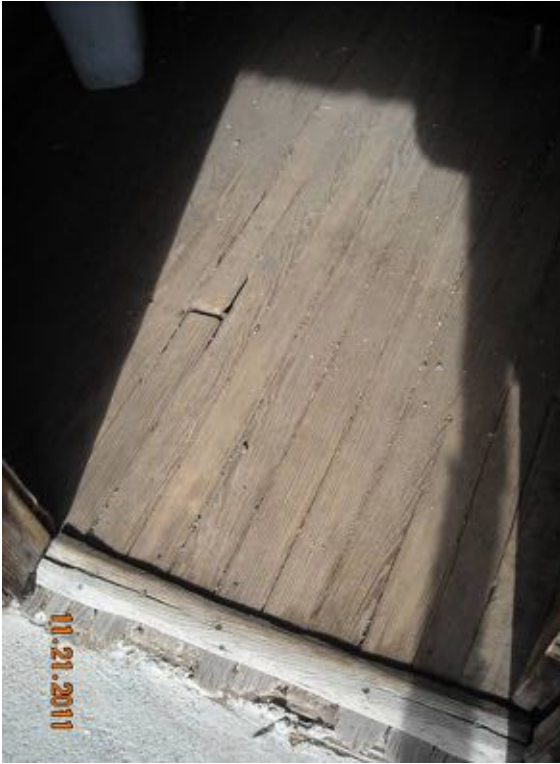
Strip tongue and groove flooring of the Cabin.  
Note the inadequate entry threshold.

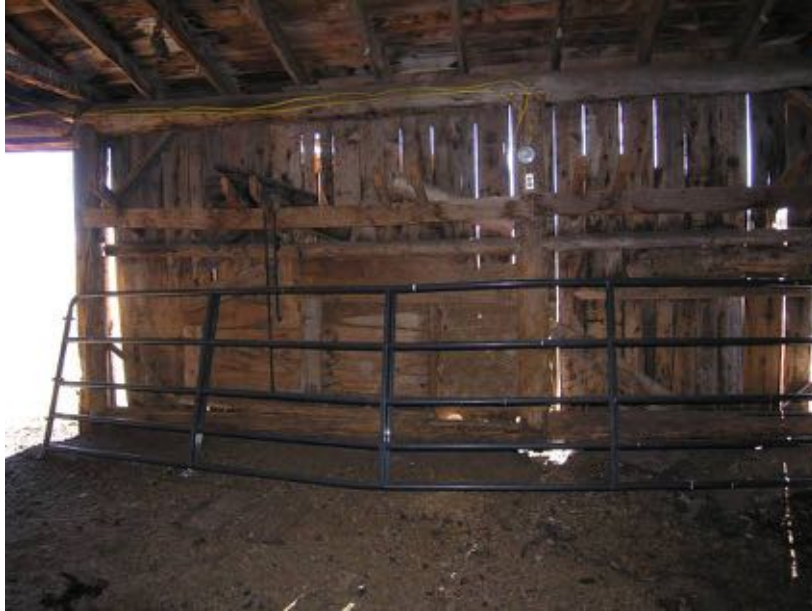
The Barn, showing surface mounted Romex wiring.
