# TARRYALL/CLINE RANCH

South Park - Park County, Colorado

## Historic Structure Assessment

October, 2011

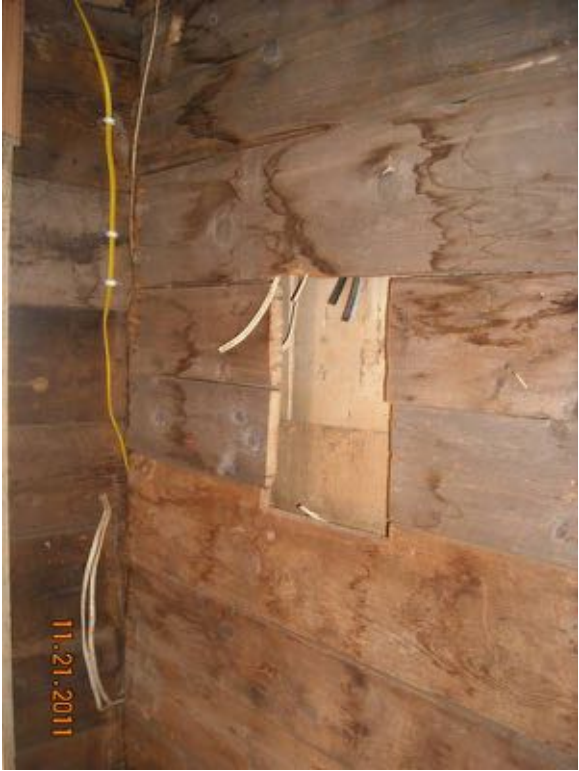
Cabin unsafe surface wiring and apparent former location of electrical breaker panel and shutoff.

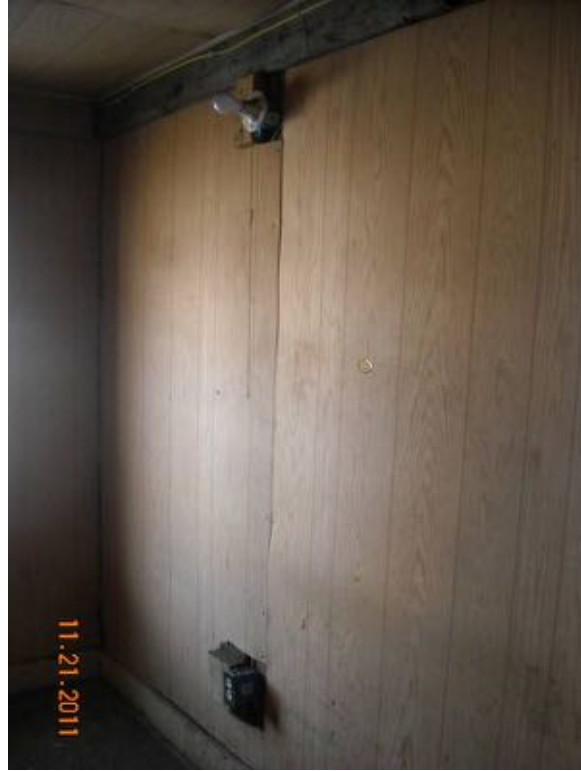
Cabin electrical wiring showing unsafe wiring exposure.
