# TARRYALL/CLINE RANCH

South Park - Park County, Colorado

## Historic Structure Assessment

October, 2011

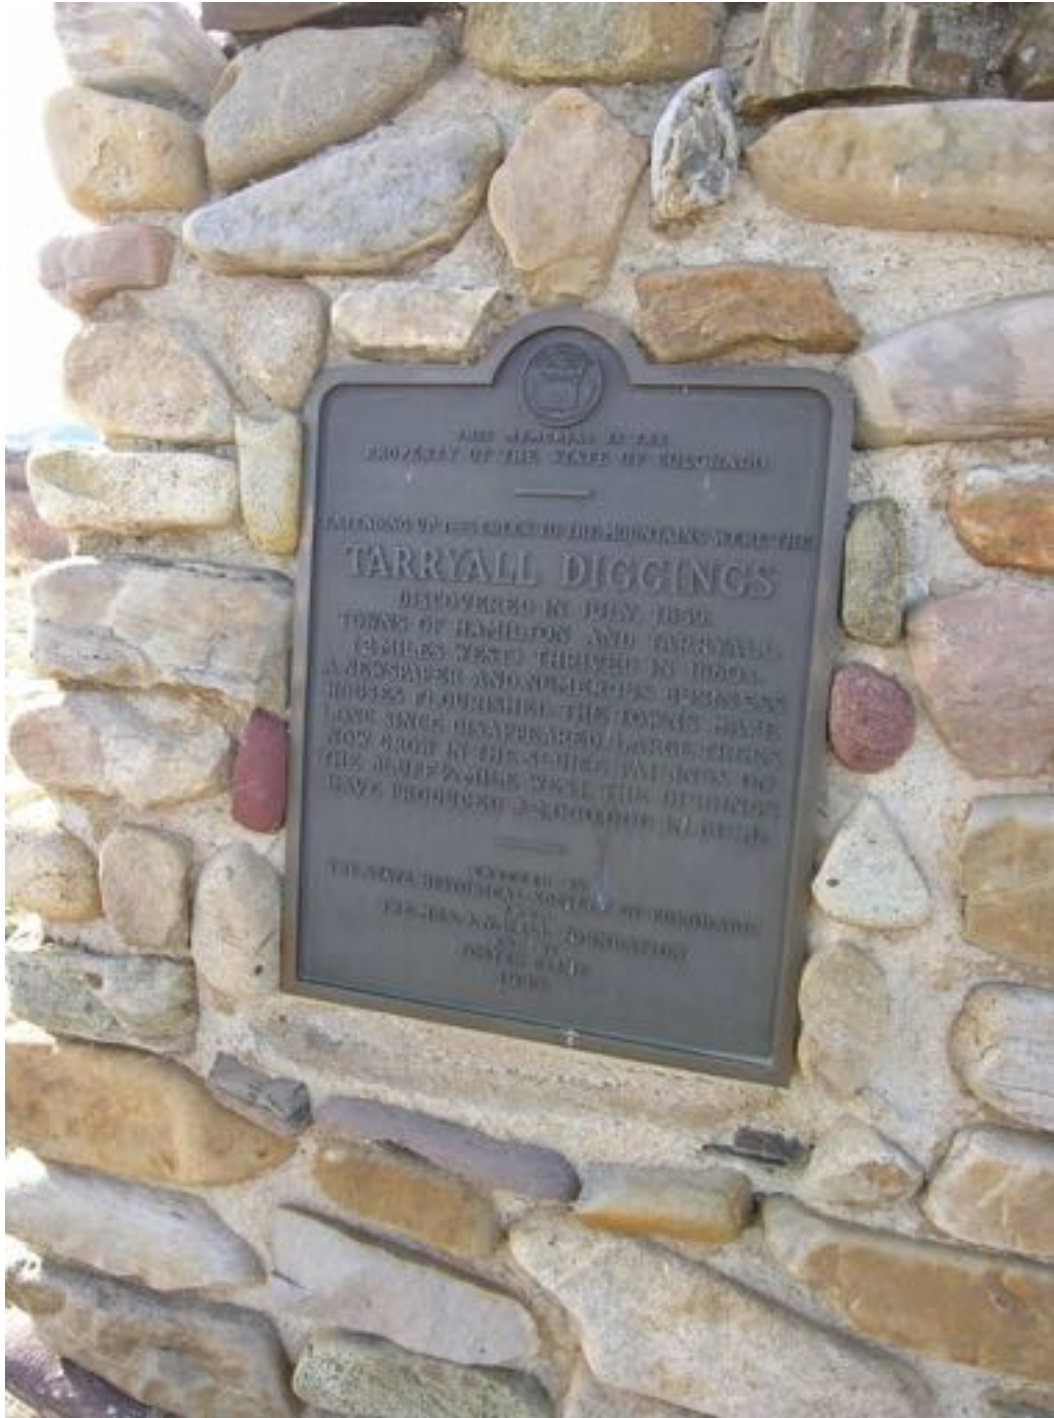
Historical marker near entry gate to the Tarryall/Cline Ranch,  
placed in 1933 by the State Historical Society of Colorado, commemorating the Tarryall Diggings  
and the mining boom towns of Hamilton and Tarryall from the 1860s. Foster Cline is listed as a donor.

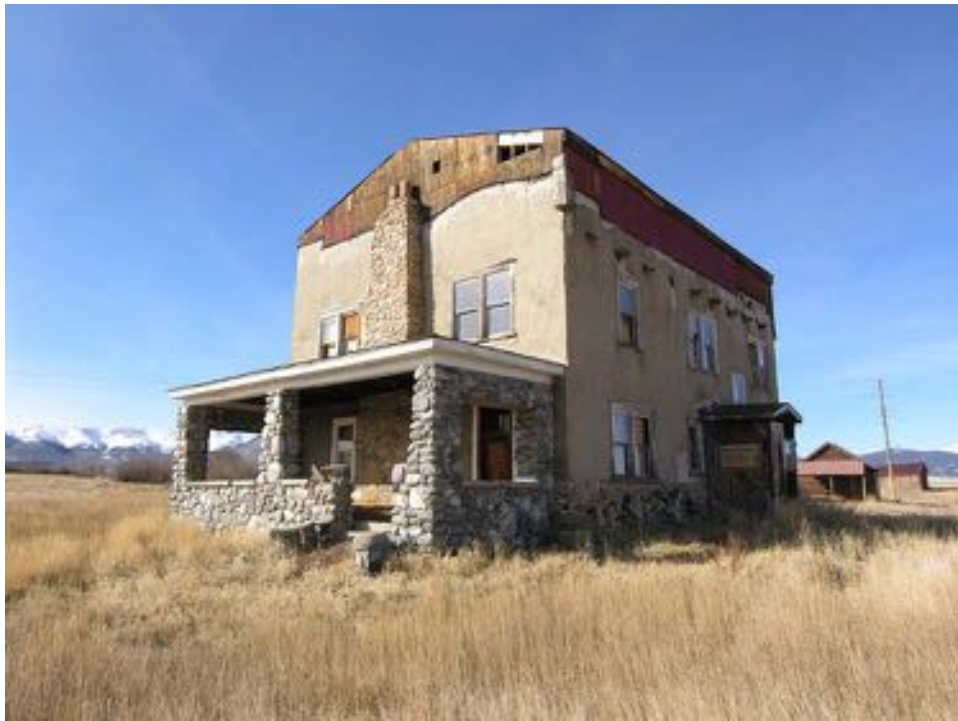
South and east elevations. Note the asymmetrical shaped original parapet with the overframed non-historic 1980s gable roof. There are also differences in the rustic stonework of the chimney and the

porch, indicating that the porch was a slightly later addition. The small entry porch on the east elevation was an alteration from the 1950-1960 era.

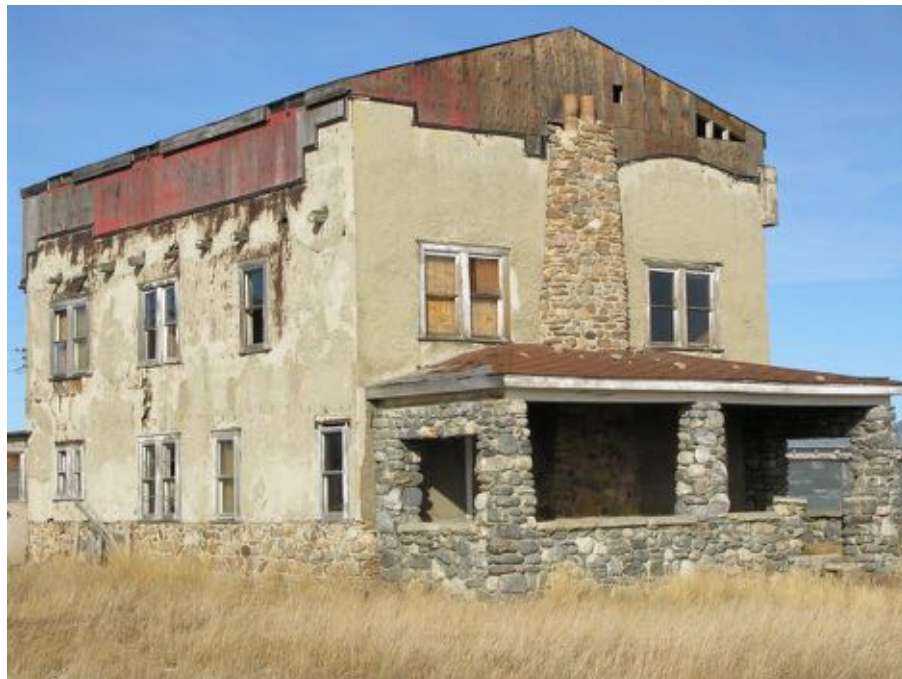
South and west elevations. Note the stucco and stone wall surfaces and the projecting vigas. The overframed roof was added in the 1980s, but the original stepped and curved parapet line is original and

unaltered. The porch roof was evidently covered with asphalt shingles originally, similar to the existing red shingles.

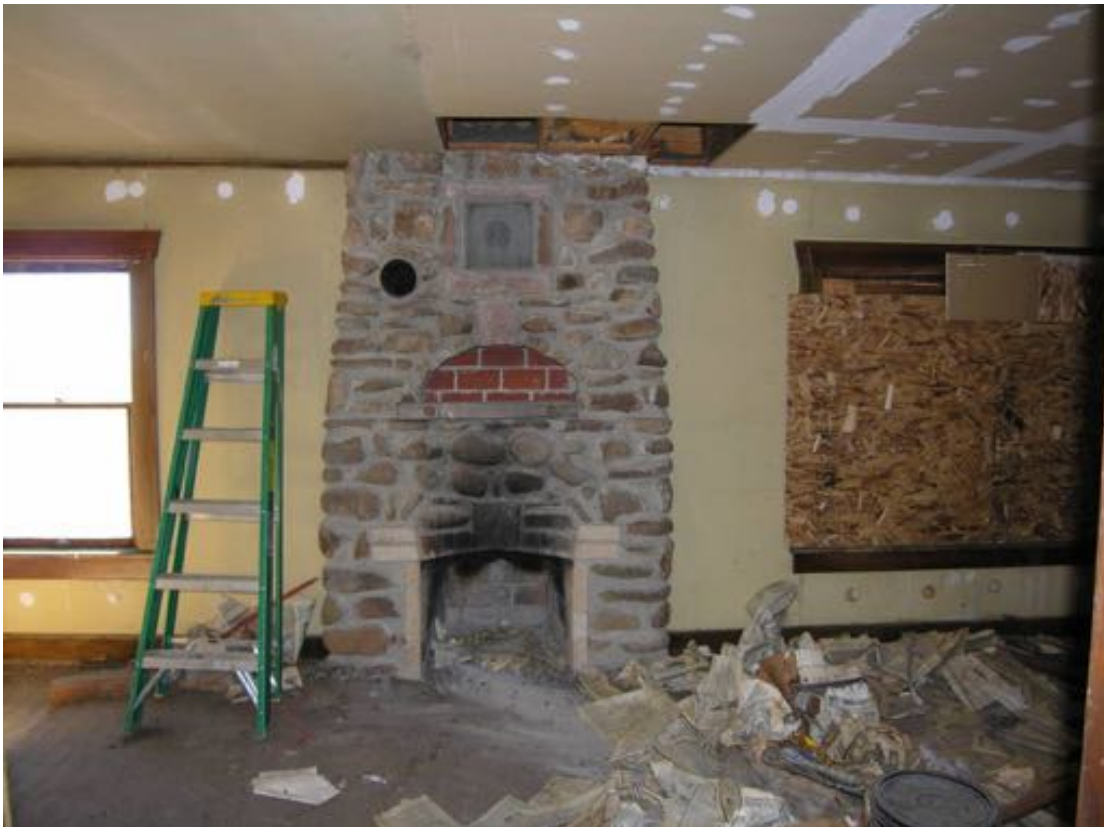
Detail of the original fireplace in room #201, a large bedroom or an upstairs sitting room. Apparently something was removed from the arched opening, but nothing specific is known and documented. Note that the walls have had a layer of sheetrock installed in recent years.

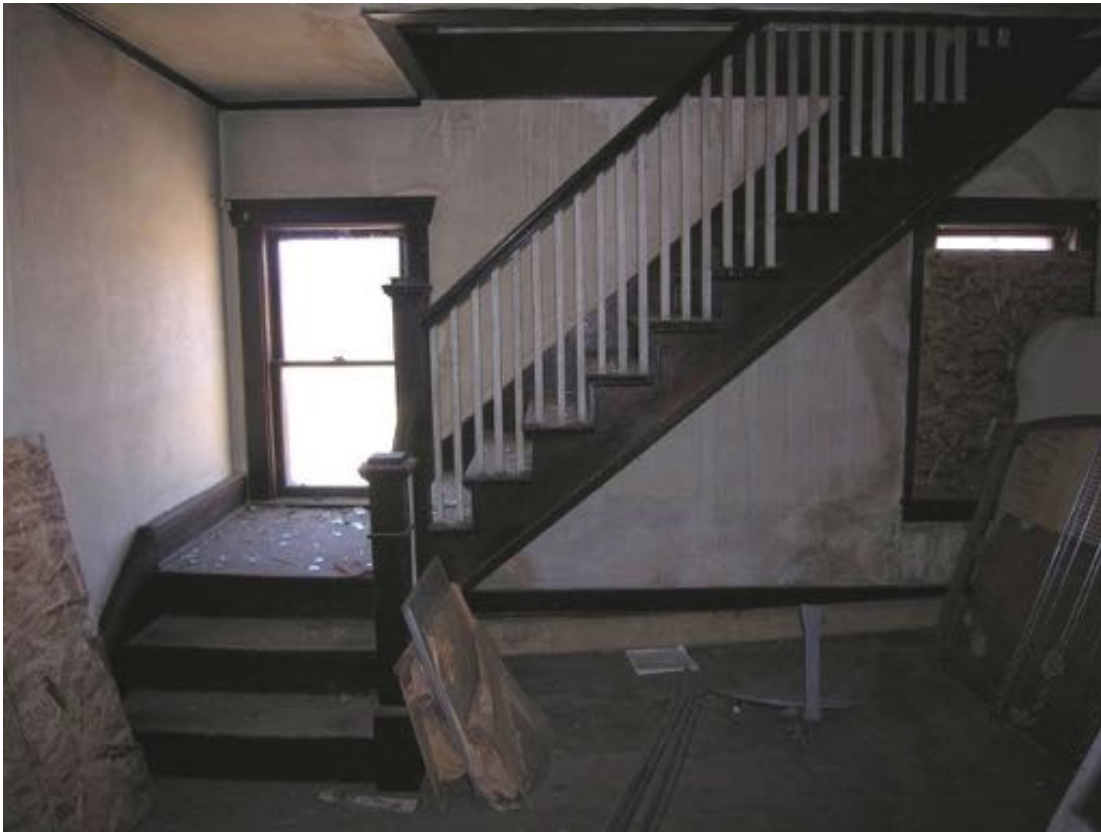
Southwest staircase from living room 101. Note that the stair is in original condition.

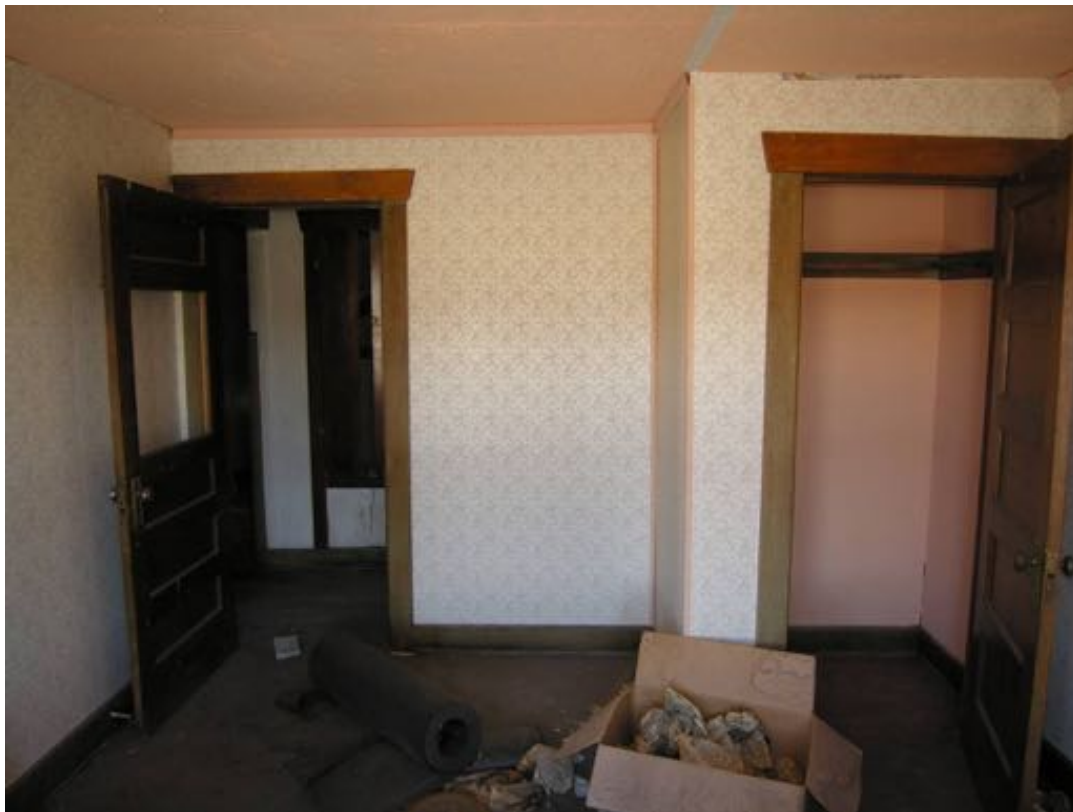
Bedroom, room 202, view to the east. Note the original flooring, walls, ceiling and woodwork – baseboards, casings and a small cornice molding. The doors are in place with their original hardware, but the door to the hall has had two panels removed and needs to be restored.

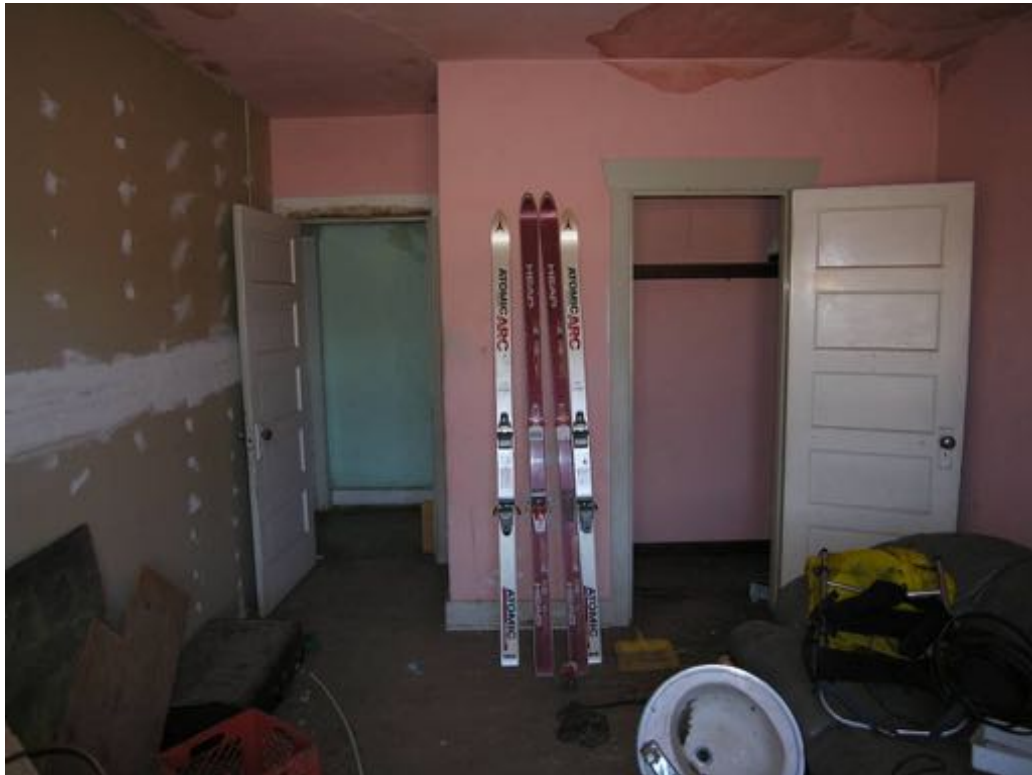
First floor Bedroom #102, view facing east. Note that the room has its original wood flooring and the walls and ceiling are original, but two walls have been furred out and covered with sheet rock that is only partially finished. The woodwork is original, but the stained and varnished finish has been painted.

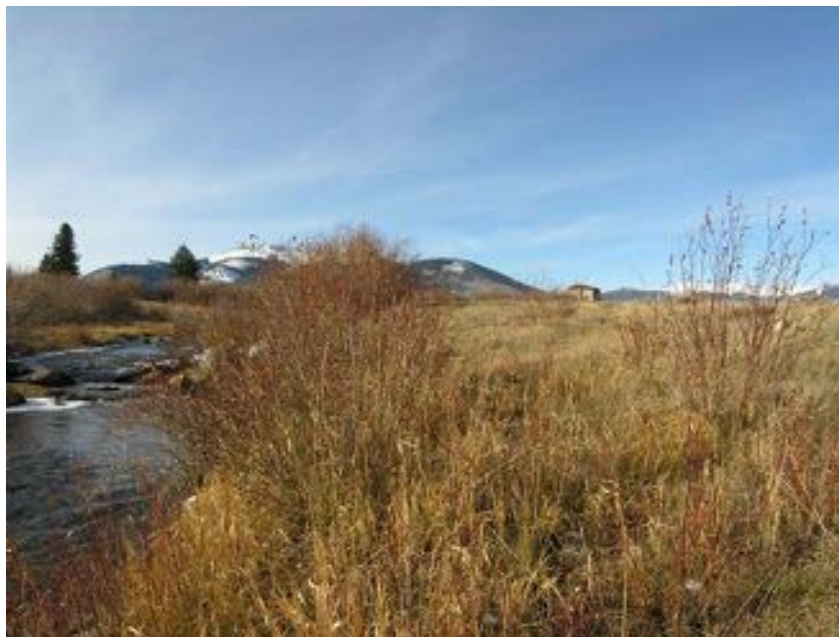
View of the site to the northwest, with Tarryall Creek in foreground. The house is visible in the distance. The landscape is natural consisting of grasses and willows.

Since the site is so flat, there is insufficient drainage around the buildings, particularly the main ranch house. It is clear that moisture pools around the foundations of the structures. Overall, the condition of the site is poor, due to insufficient drainage away from the buildings. Contributing to the site drainage problems is the proximity of the waterways and associated high water table.

2. Regrade the property around the buildings to achieve positive drainage away from the foundations. Develop a 4-5 foot dry zone at the foundations with gravel to discourage plantings and irrigation next to the buildings.

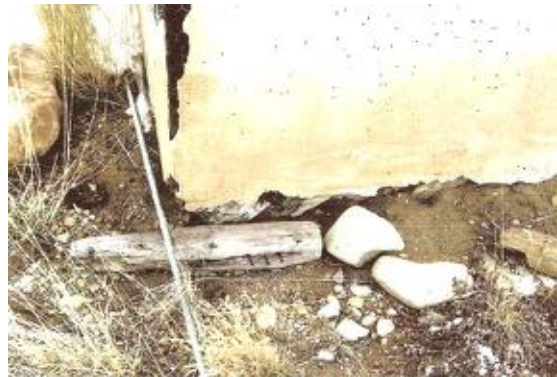
The northwest corner of the 1950s-1960s era wood frame entry/utility addition, showing no signs of a foundation.

The non historic (1950s-1960s) small north addition of the house lacks a footer and shows extensive rot at the base of the wood framing. The other wood frame entry addition on the east appears to have a concrete footer and slab.

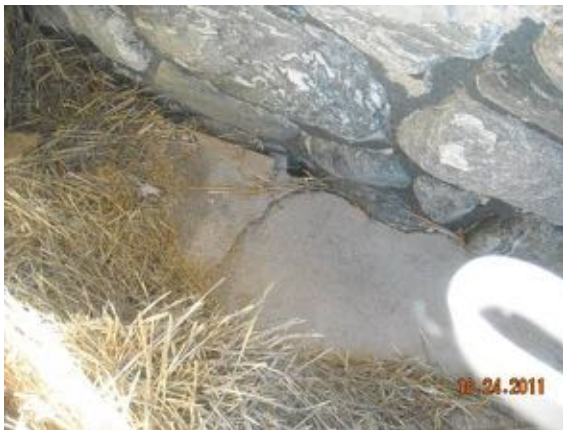
The walls of the main entry porch on the south elevation show no obvious cracks or sagging issues, implying adequate footing support. The concrete steps, however, are in poor shape, clearly lacking support, and the concrete porch deck is badly cracked.

South entry porch concrete floor, note cracking.

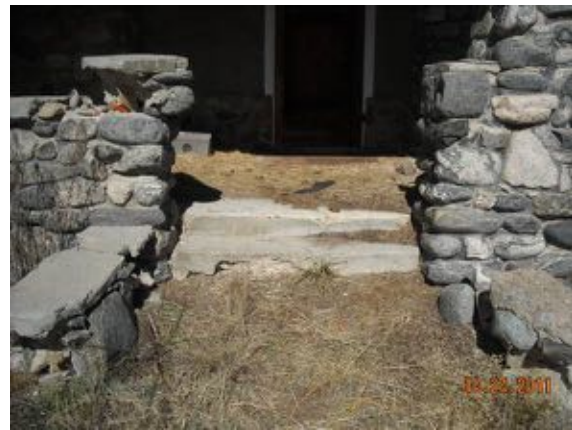
Stair to the south entry porch, note spalled and cracked concrete.

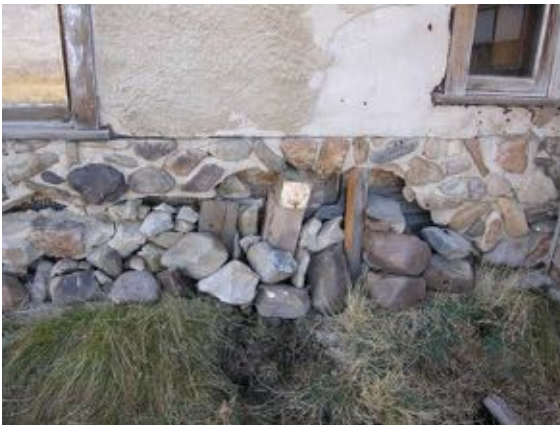
The condition of the poured concrete footer of the main ranch house is extremely poor. This footer is not entirely visible, but where it is, it shows a considerable amount of deterioration. The concrete of the footer is light tan in color with large aggregate and it has a very rough and eroded surface. The mortar used to build the veneer rock wall above the footer is similarly colored and the aggregate is very large for mortar. Clearly, the aggregate was obtained locally originally, probably from the riverbed, and the tan color of the concrete and mortar indicates that soil was mixed in with the aggregate, weakening the strength. It would appear that another factor in the weakness of the concrete is an inadequate proportion of portland cement in the original mix. This concrete of the footer has spalled, eroded and crumbled, causing subsidence and collapse of the rock veneer wall. On the east side of the house, support for the framing and parts of the floor system is now lacking, due to failure of the footer concrete. The stone and mortar veneer wall is also in poor condition, in some cases obviously because of a failure of the supporting footer, in other locations, the veneer wall appears to have buckled and

disintegrated apparently due to weakness of the mortar as well as the lack of depth and connectors to the wood frame walls and instability of the rock veneer. The primary cause of all this deterioration is moisture penetration of the masonry due to poor site drainage. It is interesting to note that the concrete and masonry of the west elevation is in much better condition than the east elevation, indicating that site drainage is better on the west.

East elevation foundation veneer wall damage.

1. Replace the existing foundation of the house with a new poured in place, reinforced concrete foundation in sections, without jacking the house up. Resupport and reconnect the existing rim joist, joists, sub floor and finished floor of the first floor system as well as the wood frame walls. The foundation design will meet building code requirements.
2. Rebuild the exterior stone cobble and mortar veneer wall as necessary, attaching the veneer to the wood framing of the floor and walls and install new flashing. All of the masonry work will carefully match the original work in every aspect of appearance.
3. Waterproof the new foundation below grade, backfill and regrade to insure positive drainage.

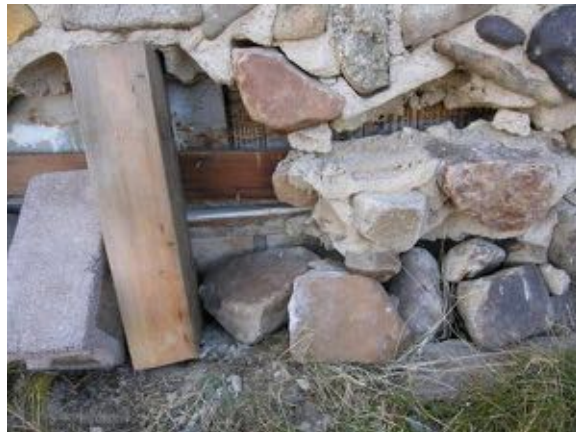
East elevation foundation veneer wall damage.

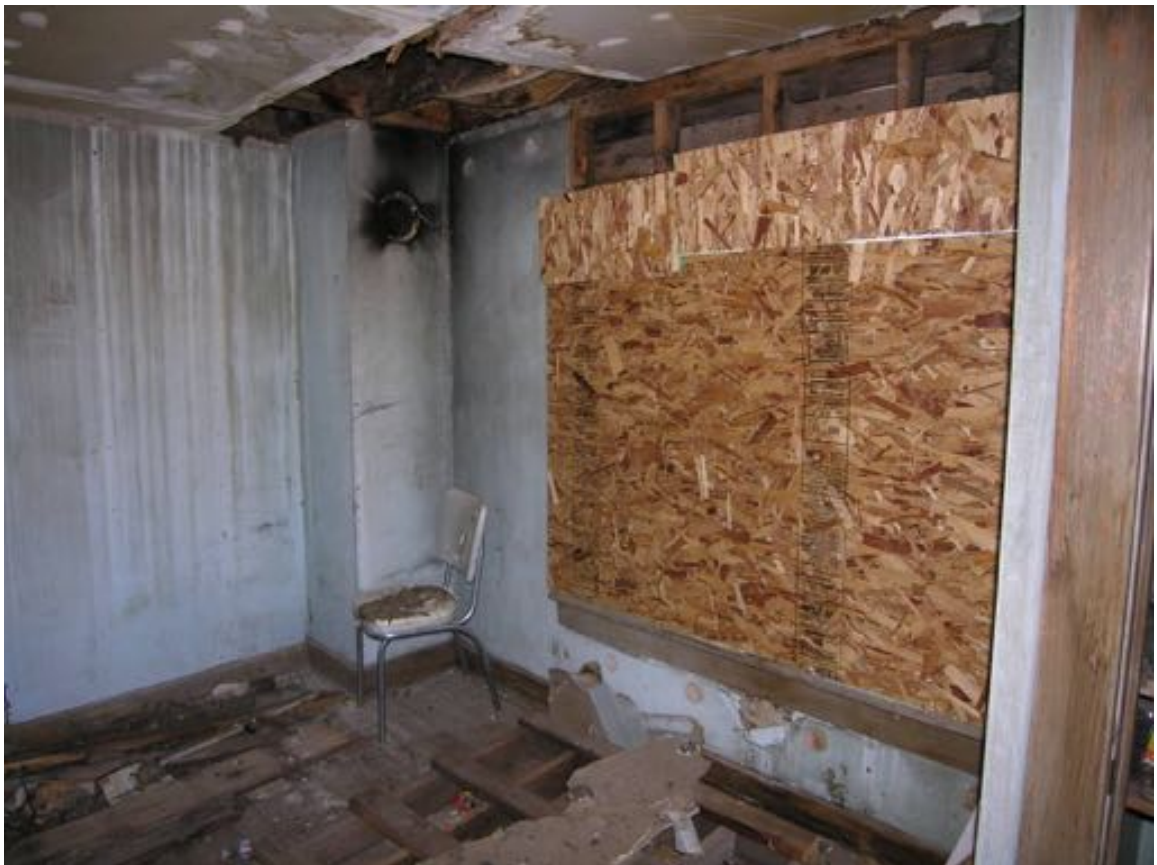
Room 204, Bedroom, the 2nd floor ceiling joists are visible through the gap in the plaster ceiling and the wall framing is visible above the OSB panels on the windows.

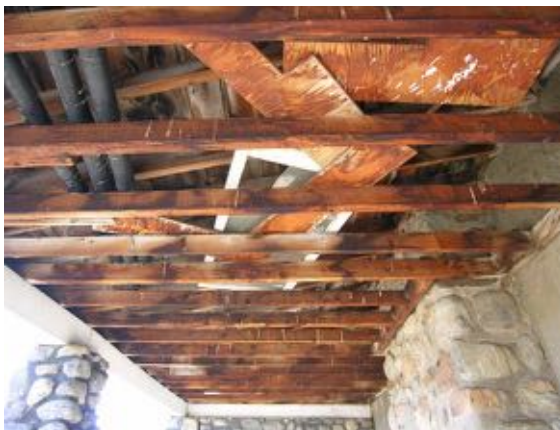
- The 1<sup>st</sup> floor joists along portions of the east wall that bear on the failed concrete footing are not adequately supported since the footing is in many areas is eroded and heavily deteriorated.
- The 1<sup>st</sup> floor exterior walls along portions of the east wall show evidence of significant movement; some walls have separated from the floor joists as well as cracked at the corners.
- The modern gable roof addition is inadequately engineered and appears to be inadequately sized, as well as being as an intrusive element that is insensitive to the historic character of the house.
- The 2"x4" rafters of the south entry porch roof and the north entry addition roof appear to be somewhat undersized by current standards.

The roof system of the south end porch, showing the exposed light framing of the rafters.

- mechanically attached to this foundation using the appropriate engineered metal fasteners.
2. Interior wall cracks must be investigated, and as appropriate, secured mechanically against further movement using the appropriate engineered metal fasteners.
  3. Carefully remove the modern gabled roof and gable end walls, repairing any damage caused by this construction.
  4. Install sistering with new rafters to reinforce the existing 2"x4" roof structures to improve the snow loading capacities for both the north entry addition and main entry porch on the south elevation.

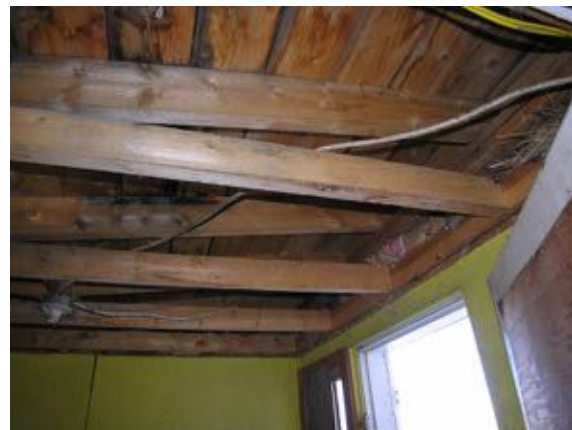
The north entry/utility addition, showing the roof framing system.

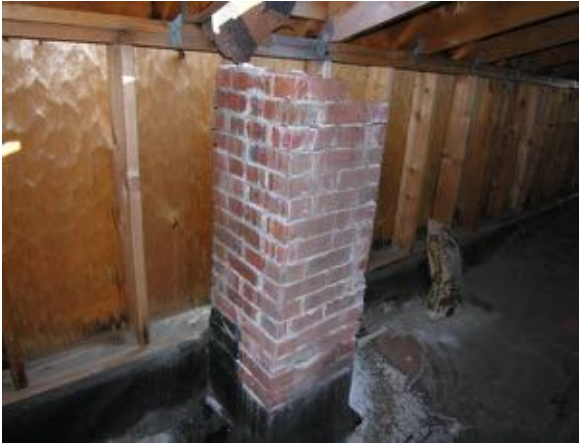
The brick chimney flue located on the east side of the original roof.

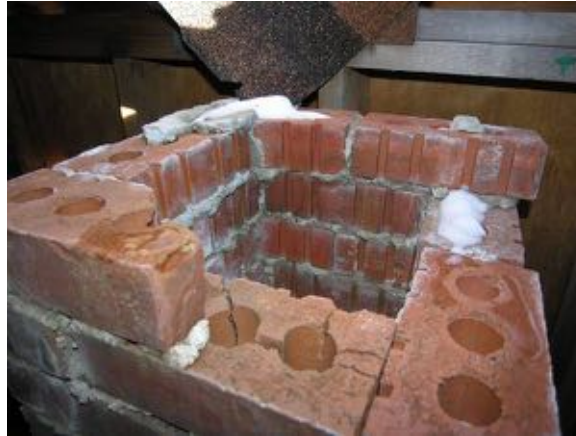
Detail of the brick chimney/flue on the east side of the original roof, now covered by the gable roof.

The hidden brick chimneys/flues are in fair to poor condition with missing brick courses and damaged mortar at the tops of the chimneys. The remaining portions of the

3. After the gable roof is removed and the original flat roof is restored, repair the two brick chimneys and add the missing courses according to the historic photographs, carefully matching the existing brick and mortar.

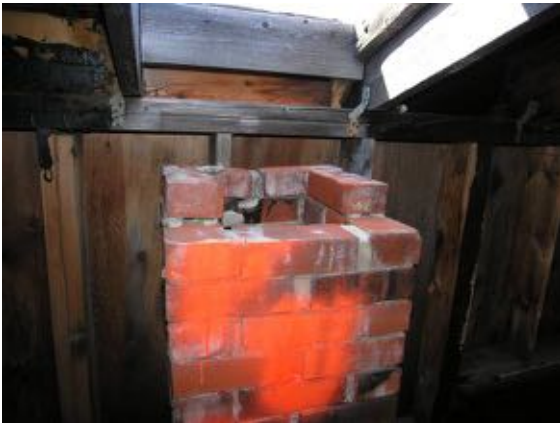
The brick chimney/flue on the west side of the original roof, note the upper courses of brick are missing and the mortar is crumbled at the top.

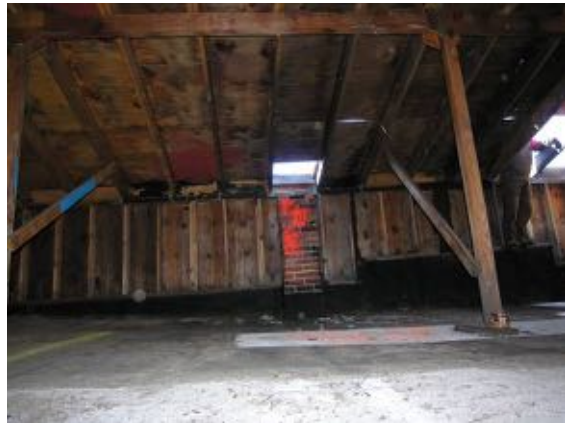
The brick chimney/flue on the west side of the original roof.

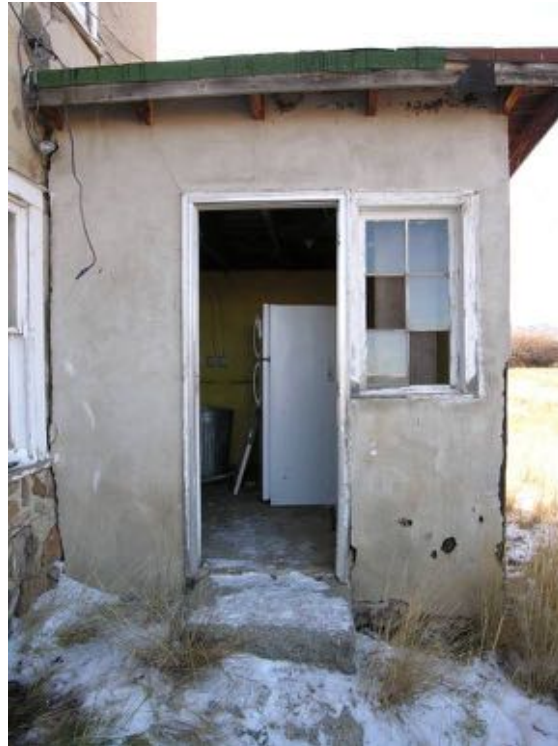
The north entry addition from the 1950s -1960s replaced an earlier detached coal shed. This stuccoed addition was built when the door on the north elevation was moved from the original location on the north wall to the other side, inside this shed.

The north addition shed roof appears to be in fair to poor condition, with no bare spots visible, but with inadequate sealing and lapping of the existing roll roofing. There are no signs of metal flashing between the roof of the addition and the main wall of the house, so there is nothing to prevent water from entering the house through the roof at that juncture. Since there is no guttering or downspouts on the north entry addition, water drains down on the stucco walls.

7. Remove the non-historic east entry addition and restore the original window in that location.
8. Repair and rehabilitate the north entry addition to maintain the utility functions and provide a mud room and airlock for the kitchen. After the foundation is rebuilt, repair the existing stucco walls as per item #2 above.

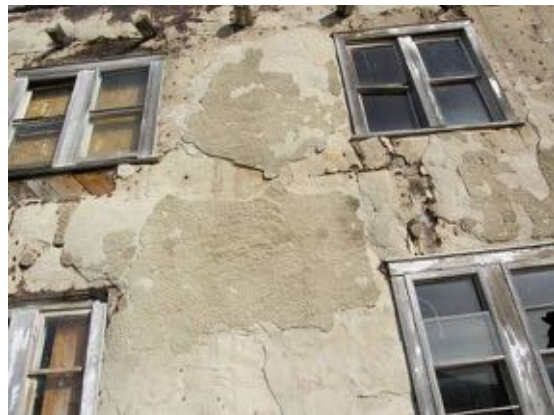
eroded and has lost its connection with its anchoring wire mesh, and also seems to have delaminated, with the top coat of stucco separated from the bottom coat. Additionally, the wire mesh has rusted and deteriorated due to exposure to moisture, because of the general deterioration and loss of the stucco covering. It appears that the stucco suffers from the same problem as the foundation stonework in that it seems the stucco is lacking sufficient Portland cement in the original material. The stucco seems to have been too soft to withstand the weathering of the past 80+ years. The underlying wood sheathing is exposed in some areas where the stucco has fallen off the wall. Large areas, particularly on the west side, show signs of bulging stucco, a suggestion that the anchoring wire mesh has pulled away from this plank sheathing.

Detail of the heavily deteriorated stucco on the west elevation, with the wood sheathing exposed where the stucco is completely eroded. Also note the rotted or missing vigas.

5. Remove all of the loose or deteriorated stucco on the walls and secure the existing wire mesh as possible and install new expanded wire mesh/lath as needed. Replace the deteriorated and missing stucco using new stucco to match the original in color, appearance and texture, but formulated appropriately in composition.

6. Remove the existing rotted vigas and replace with new preservative treated log vigas to match the originals in appearance and flash appropriately.

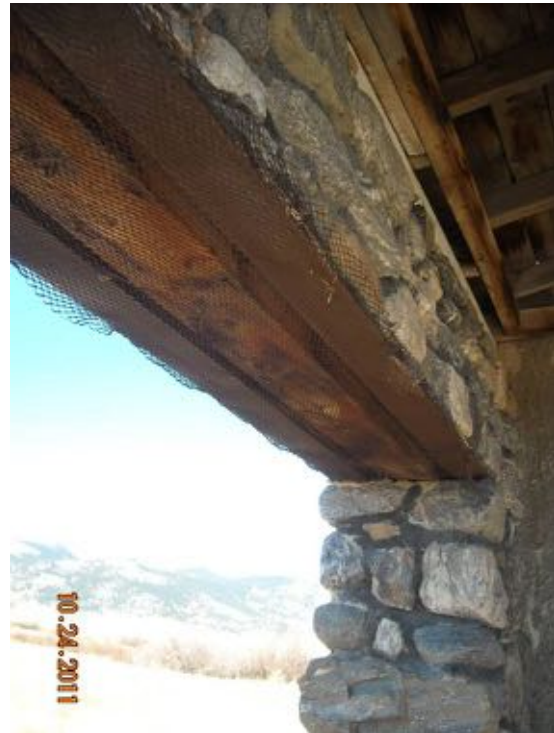
Header detail of the main entry porch, west end, on the south elevation; note the wood and wire mesh evidently intended to support stucco.

2. Repair and repoint the deteriorated stonework of the main south entry porch, matching the composition, color, finish and tooling of the existing original mortar. Stucco the east and west headers to match the concrete ledge caps. Repair and parge the deteriorated concrete ledge caps or sills with concrete to match the original in color and finish.

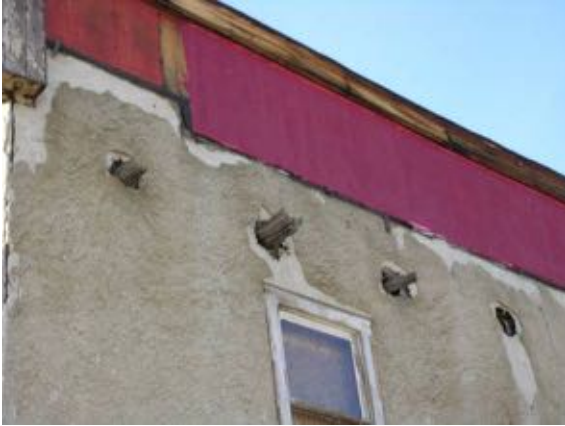
The log vigas are all in poor condition and heavily rotted; some have fallen out of the sockets and are missing altogether. These, of course are not structural roof beams, but log ends inserted in the wall.

The rotted and missing log vigas on the east elevation, these are not structural.

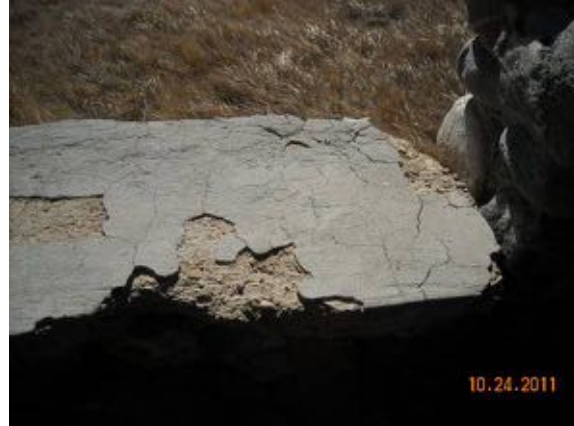
The walls of the main entry porch on the south elevation appear to be in fair to poor condition, though there is significant spalling and deterioration of the concrete ledge caps or “sills”. In addition, the concrete floor and steps are heavily cracked and settled, causing small gaps between the concrete and walls of the porch and the house. It should

The spalled and eroded concrete “sills” or ledge caps on the main south porch.

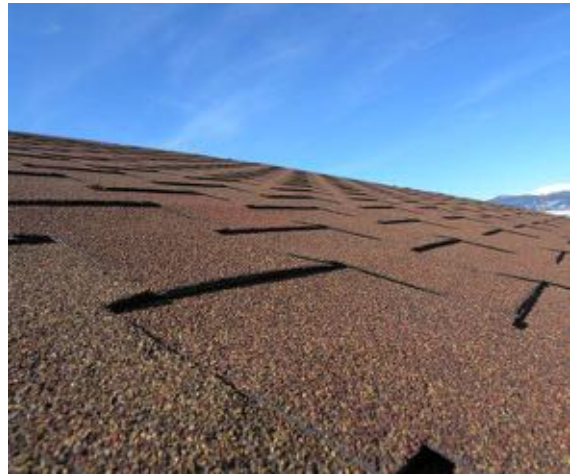
Looking up a relatively secure section of the modern gable roof, showing relatively stable shingling.

1. Carefully disassemble and remove the existing 1980s overframed gable roof without damaging the historic flat roof deck or the parapets.
2. Remove the existing flat roofing materials from the original roof and inspect the roof decking. Replace any deteriorated or inadequate sheathing boards to achieve a sound surface for re-roofing. Install a new roofing system appropriate for this gently sloping surface which such as an EPDM or similar product that will wrap the parapets as well as the deck. The new roofing should be carefully sealed and

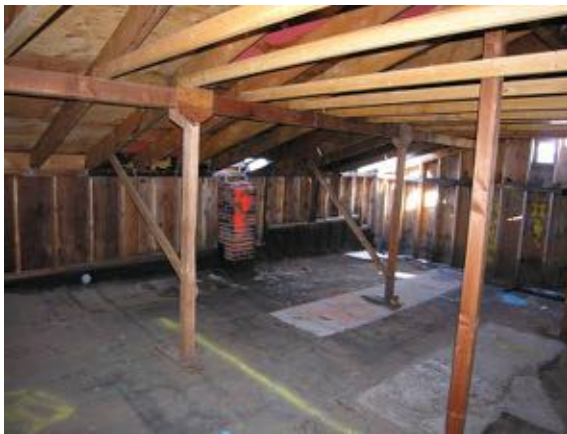
The original roof that lies under the 1980s gable roof addition is in poor condition. The existing flat roofing system is inadequate to shed moisture effectively and undoubtedly

Original roof deck and parapets, over framed with modern gable roof, view to the northwest corner.

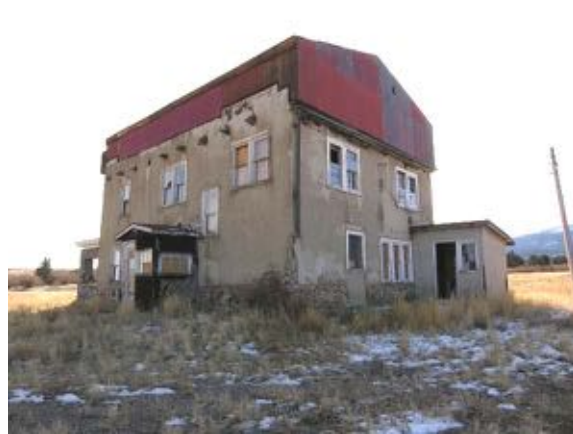
Exterior, east and north elevations and entry additions.

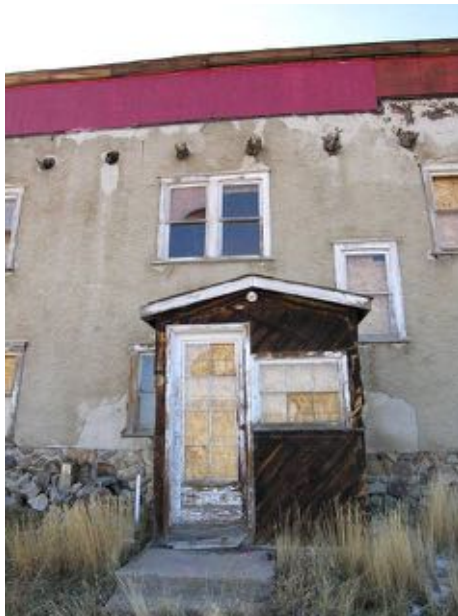
The east side entry vestibule roof is in poor condition. Roofing is missing in areas, leaving the wood sheathing exposed. This structure has separated from the house, leaving a sizable gap and any flashing that might have previously sealed this interface is not visible.

East entry addition built in 1950s -1960s and the construction was never finished. The opening through the exterior wall of the house into room #107 was a window originally, not a door.

The non-historic east entry addition should also be removed and the original window restored in that location, therefore no recommendation for reroofing will be made for this addition. The remaining roofing on the south entry porch and the north entry porch should be removed and new roofing installed with appropriate flashing and drip edging.

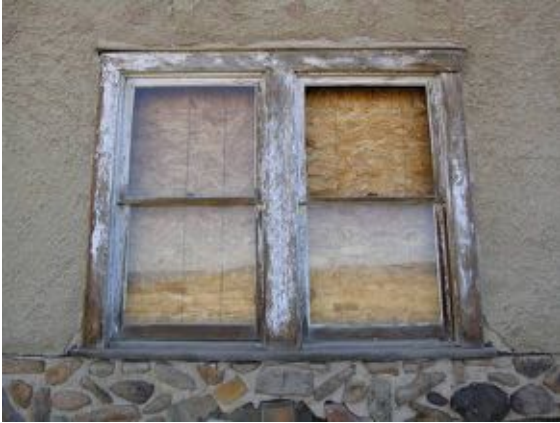
Close view, typical window pair, east elevation,  
note the missing glass.

wood windows themselves are relatively sound, much of the glass is broken, the putty is deteriorated and the exterior paint is peeling, cracked and deteriorated. Additionally, the sash cord and counter weight system is not consistently operable and in many cases the cord is broken or missing. All of the exterior window and door trim is deteriorated, with peeling, cracked or missing paint. The window sills, in particular, are heavily weathered and checked. While there are a few storm windows in place, most are missing. The thermal efficiency of the windows would be improved by adding appropriate storm windows and weatherstripping on all the windows.

Architect. Replace all broken and missing glass panes and any deteriorated putty with new putty. Repair any cracks in the wood surfaces with an epoxy repair system. It is likely, due to the age of the building, that the existing paint contains lead. Follow all applicable regulations and take all appropriate precautions when scraping, sanding and prepping for repainting. Follow the directions in the Department of the Interior's Preservation Brief, *The Repair of Historic Wooden Windows*.

4. Restore the windows to full function by repairing the sash cord and counterweight system for each window as needed. Replace missing sash latches to match originals. Install weather stripping in each window.
5. Fabricate and install new storm windows for every window opening as unobtrusively as possible.
6. Reset the missing interior doors in their original locations and repair the hardware as needed. Repaint or restain and revarnish as needed.
7. Restore the missing wood panels in the two interior doors that were altered and refinish to match.
8. Restore the original door on the north elevation at the east end (unless the handicapped ramp is built on the north elevation, then restore the opening with the window.)

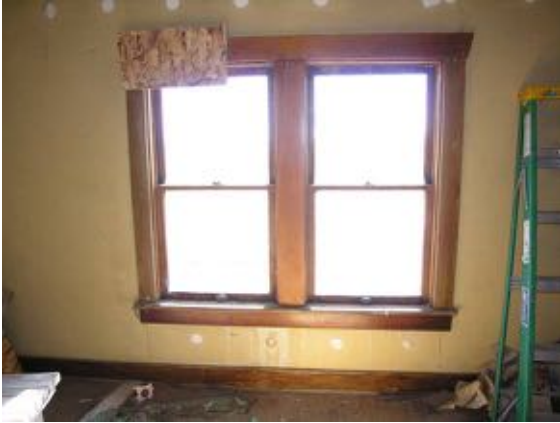
Windows, room #201, note stained and varnish finish as well as the baseboard. Note the drilled patched, holes from insulation work.

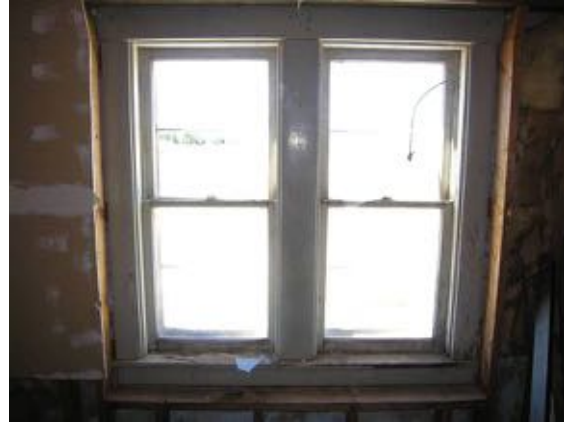
Windows, room #102, note painted finish. Note the furred out walls and unfinished drywall.

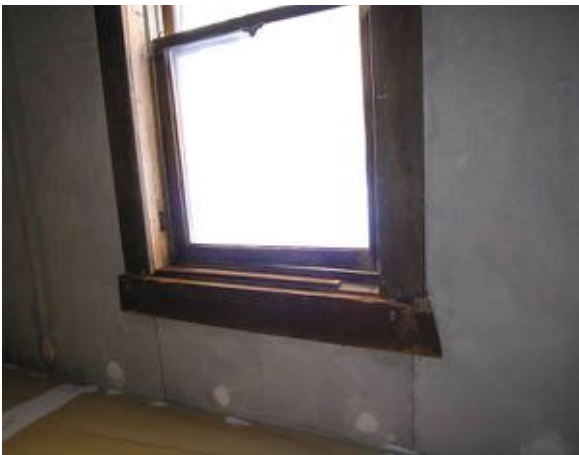
Southwest stair window, note stained and varnished finish on the window and casing. Also note the drilled holes that were patched after an insulation project in recent years, apparently.

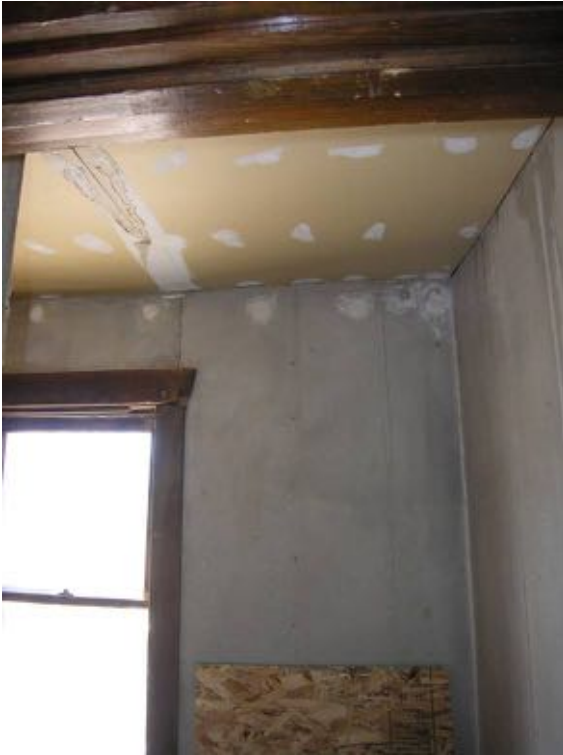
Southwest stair, view to the west. Note the unfinished drywall on the ceiling and patched holes in the wall from insulation installation.

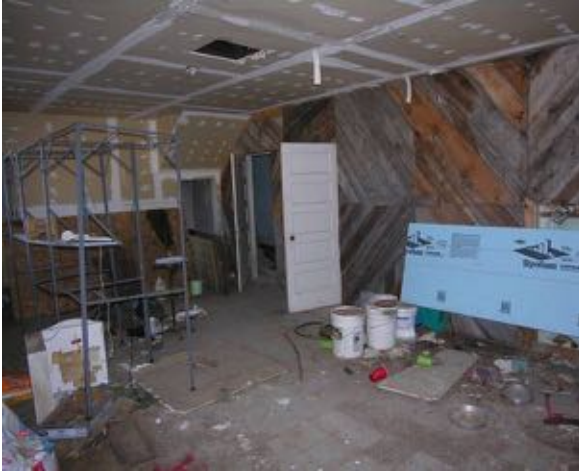
Interior, kitchen, room #105, view to the southeast. Note the barn wood on the wall and the unfinished sheetrock on the ceiling and east wall.

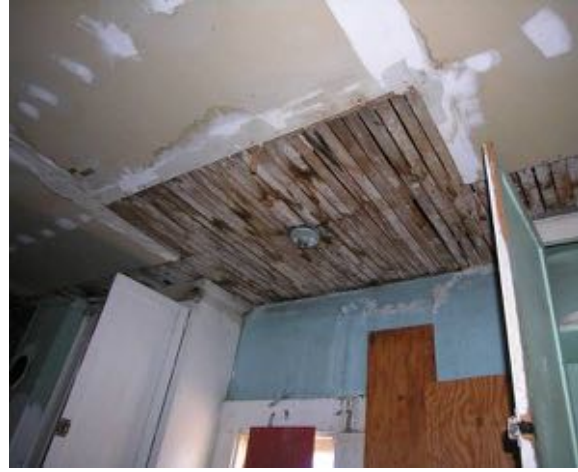
Interior, kitchen, room #105, view to the west. Note the exposed wood lath under the sheetrock and the painted kitchen cabinets.

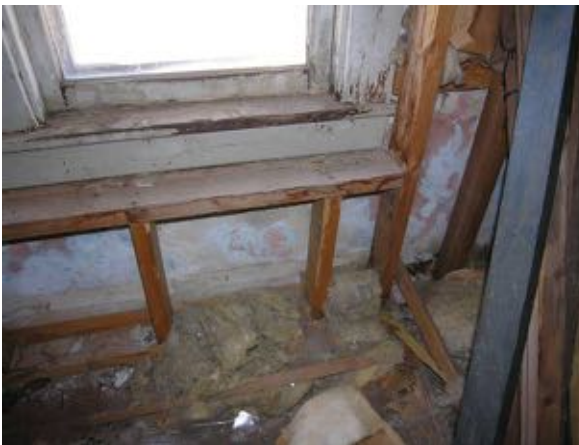
Interior room #102, view to the west. Note the 2”x4” furring over the wood lath and plaster.

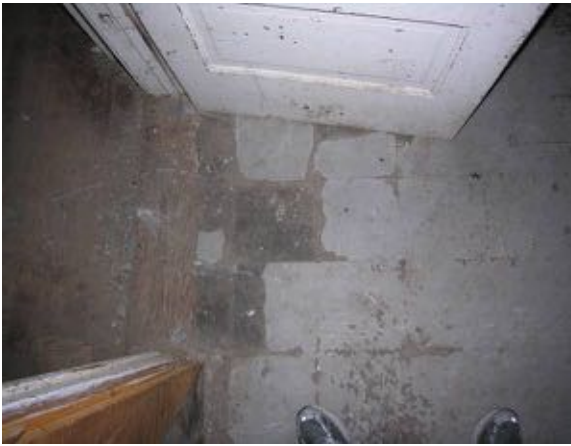
Remnants of a tile on the kitchen floor. Note the wood strip flooring underneath.

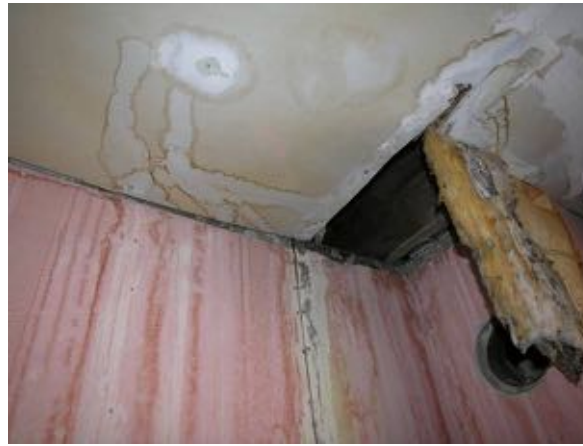
Water damage in a second floor bedroom ceiling. Note that the ceiling material is an added layer of paper-sided gypsum board.

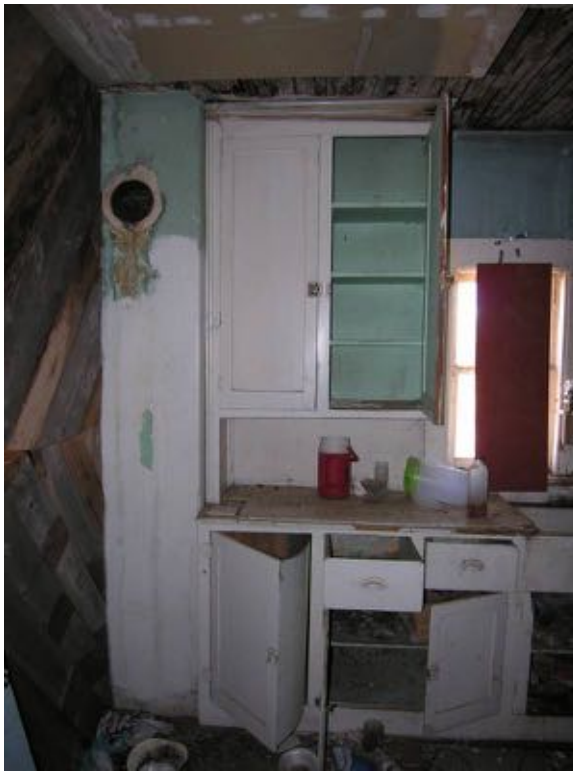
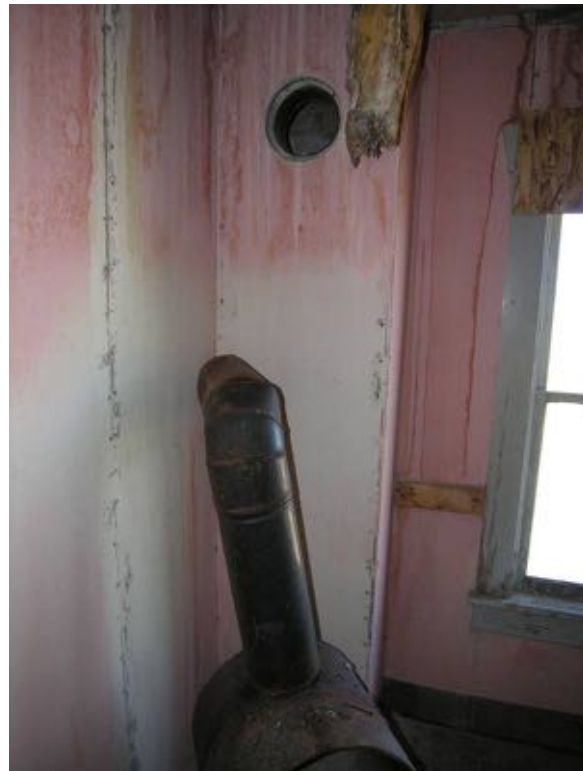
First floor kitchen showing chimney and flue hole. Second floor bedroom, showing stove and chimney.

It is unclear whether any of the two chimneys are in working order, free of obstruction and any cracks and flaws that might endanger the house with fire. All of the chimneys need to be inspected.

1. All chimneys should be lined with stainless steel to assure the integrity of the smoke exhaust structure.
2. Depending upon the ultimate use the house is put to, it will be necessary to engineer and install an unobtrusive heating system, probably using the nearby electrical service.
3. With the services of a licensed plumber, new water supply lines and new plumbing fixtures need to be installed, depending on decisions about the use of the house.
4. The drain system needs to be assessed and scoped with the use of a micro-camera. Locate the septic tank, inspect for integrity, and assess the presence of a leach

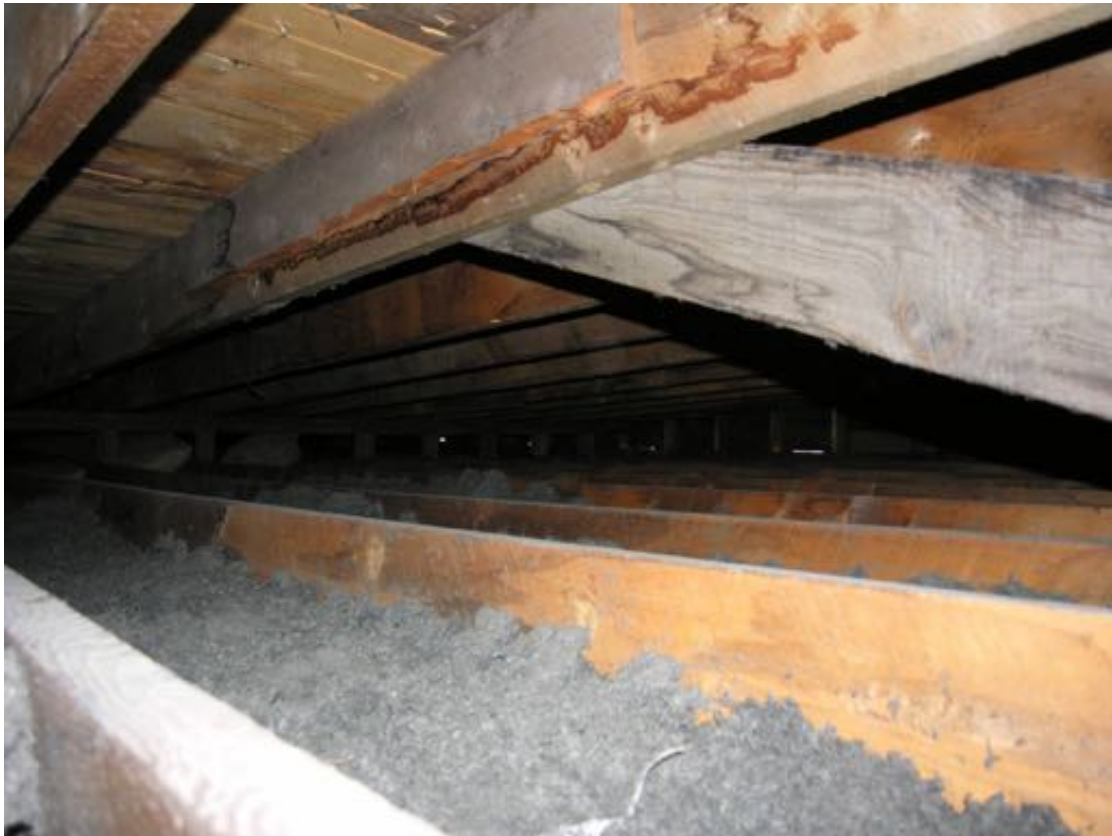
The loose fiber, grey in color, used as insulation in the ceiling of the second floor of the house was tested and found to be non-hazardous. Otherwise, the house has not been tested for hazardous materials, but there are two elements of the building that are possibly hazardous: lead based paint on the interior and exterior, likely due to the age of the building and the vinyl tile and adhesives on the floor of the kitchen.

Loose fill insulation between the ceiling rafters above the second floor of the house.

1. All suspicious building materials should be tested and evaluated by a hazardous materials specialist (who would determine the suspicious materials.)
