# TARRYALL/CLINE RANCH

South Park - Park County, Colorado

## Historic Structure Assessment

October, 2011

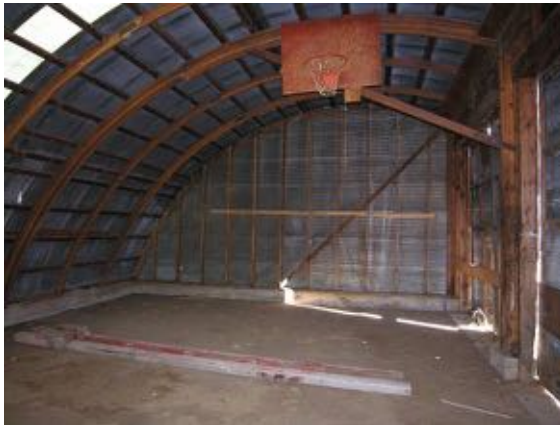
The concrete footer for the Quonset is clearly evident.

The Quonset footer appears in good condition.

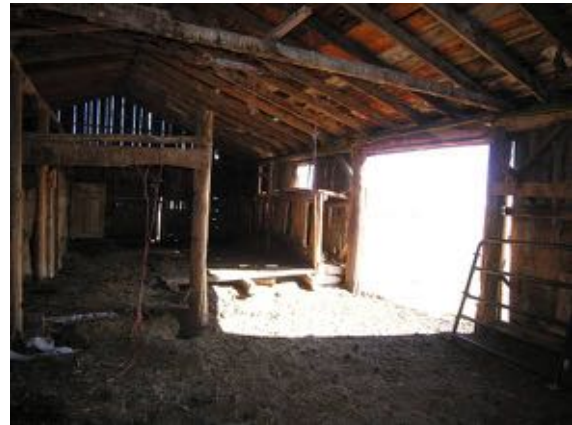
The Barn is constructed pole barn style, with vertical foundation posts.

The Barn has rot issues with the post where they meet the ground. In at least one case, a post is completely disconnected from the ground due to rot or decay.

1. Lift the Cabin and install an engineered, poured footer to support the structure above. Replace rotted sill lumber and reattach with engineered metal fasteners to the new footer.
2. Replace rotted posts of the barn with pressure-treated lumber to match in size when more than half of the post displays rot at the ground level.

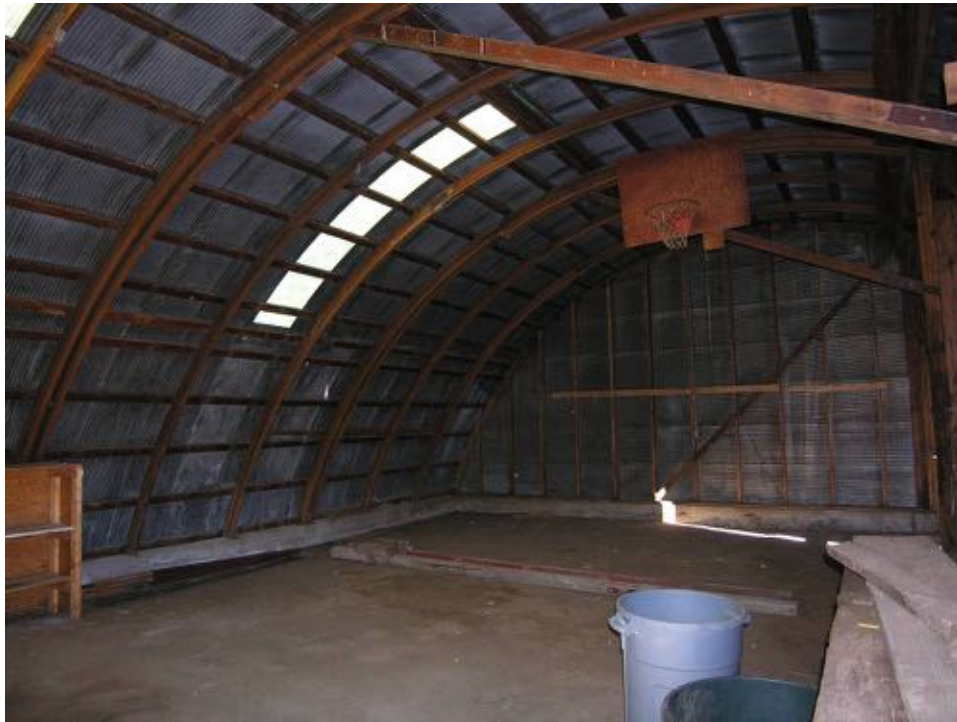
The Quonset has a series of arched laminates tied with wood battens. The end walls are studs.

The Quonset appears in stable condition.

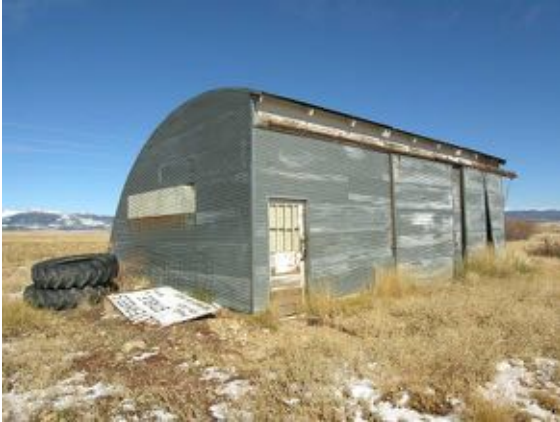
Quonset, south elevation. Corrugated metal material covers the frame below.

The Quonset siding appears in stable condition.

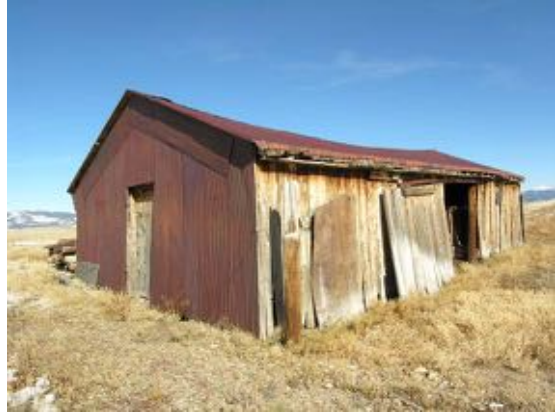
The Barn, viewed to the north west. The south elevation is wood and clearly deteriorated. The west elevation is sheathed over in sheet metal.

The Barn siding is in rough condition, but this is not unusual for a barn structure of this age.

1. Carefully remove the horizontal mill-waste siding to such a point as to expose the base sheathing. Apply a house wrap to the structure before reapplying the siding. The east elevation and other areas where the mill-waste is damaged, replace with a siding of similar construction.
2. The Barn siding would resist rot and decay better when it is treated with an oil based preservative.

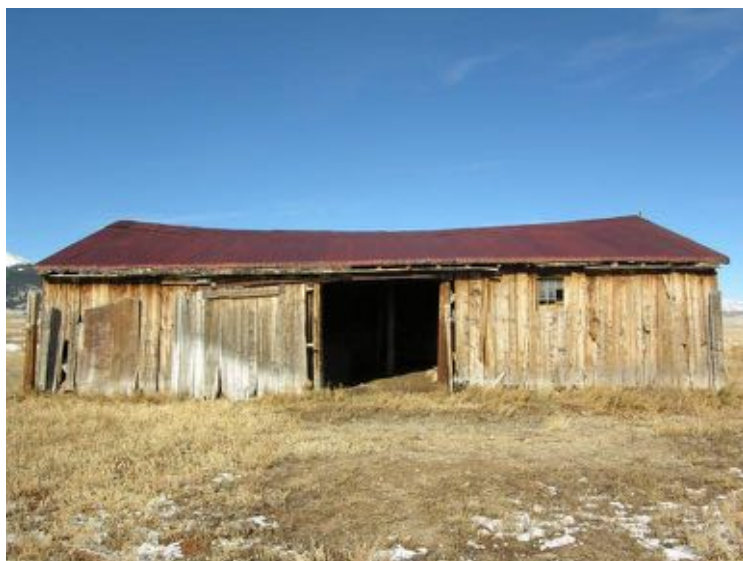
The Barn is roofed with unpainted corrugated sheet metal.

The Barn roof is in poor condition..

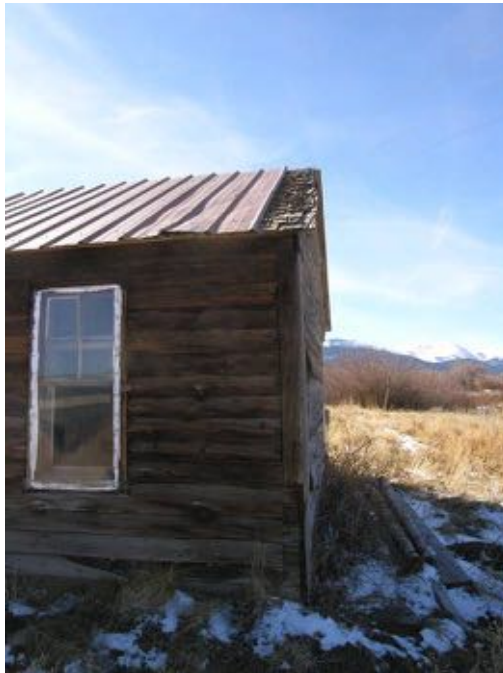
The Cabin roof is inadequate and in poor condition. The fastener pattern of the sheet metal is inadequate and lacks any metal rake-edge flashing or drip edge.

The roof of the Cabin, here looking to the west. The sheet metal roofing overlays sawn, wood shingles.

1. Remove all roofing from the Cabin down to the roof sheathing boards. The sheathing boards should be replaced if they are damaged or rotten. Apply a rubberized plastic ice and water shield to the entire roof and install rake edge and drip edge galvanized metal flashing. Replace the sheet metal roof, using screws in the pattern approved by the roofing manufacturer.
2. Carefully apply black plastic roof cement unobtrusively to obvious holes and gaps in the existing metal roof of the Quonset roof, and add screws to secure the metal to the sheathing underneath.

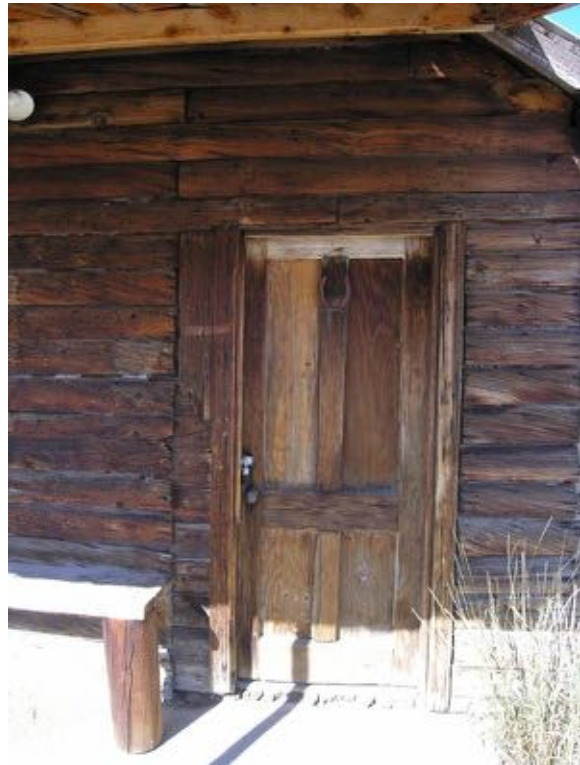
South elevation, Cabin, unfinished entry door.

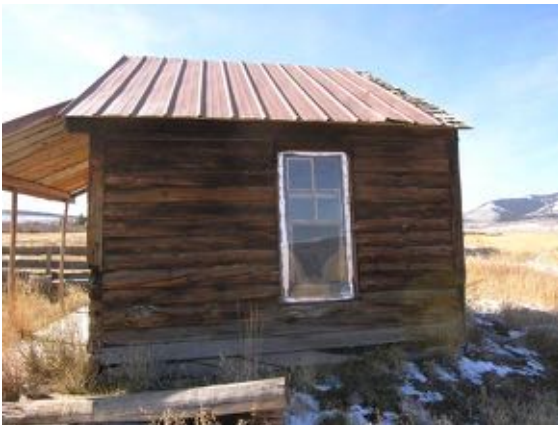
Cabin, east elevation, showing missing sash and plexiglass covering.

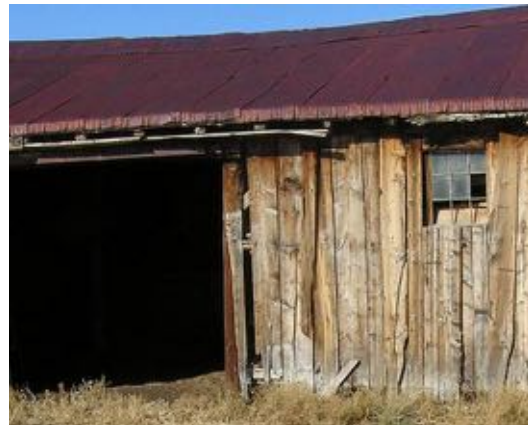
The south elevation of the Barn, showing window sash.

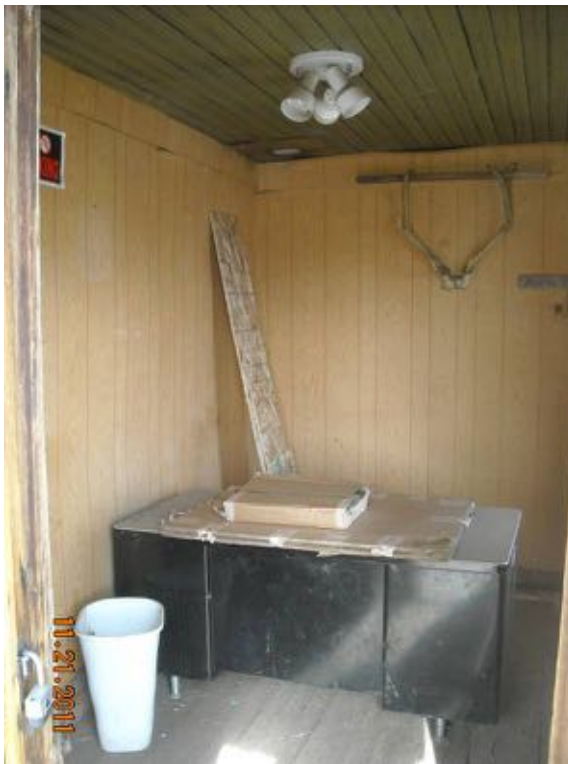
The front room of the Cabin, showing paneling and beadboard ceiling.

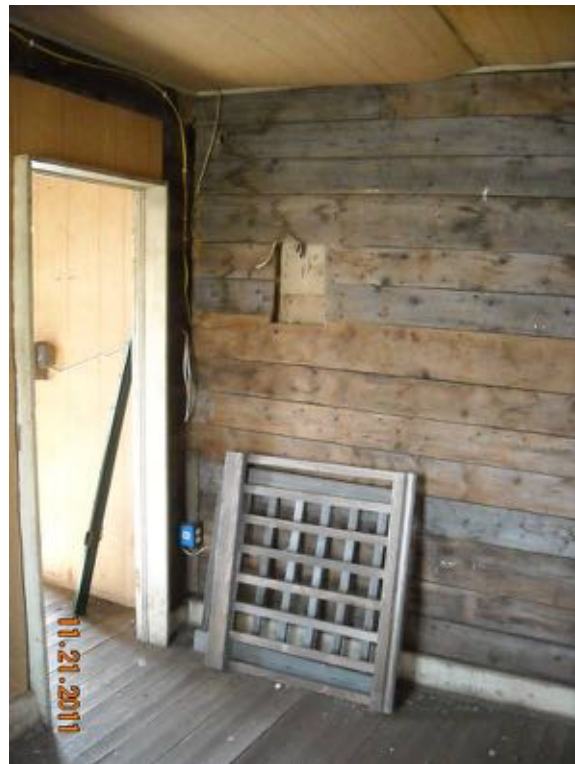
The back room of the Cabin, showing rough plank walls, beadboard ceiling, and strip tongue and groove flooring.

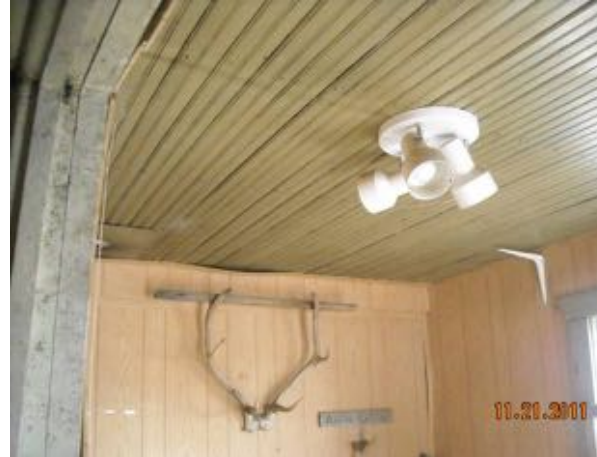
Ceiling of the front room of the Cabin

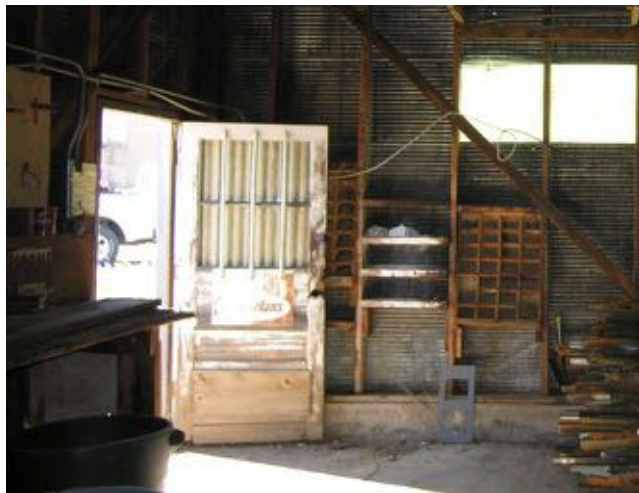
Interior of the Quonset, showing steel wire conduit
